Stinger Heigh10 Install Guidance for Land Rover Defender Kit - UN1810E-LR1

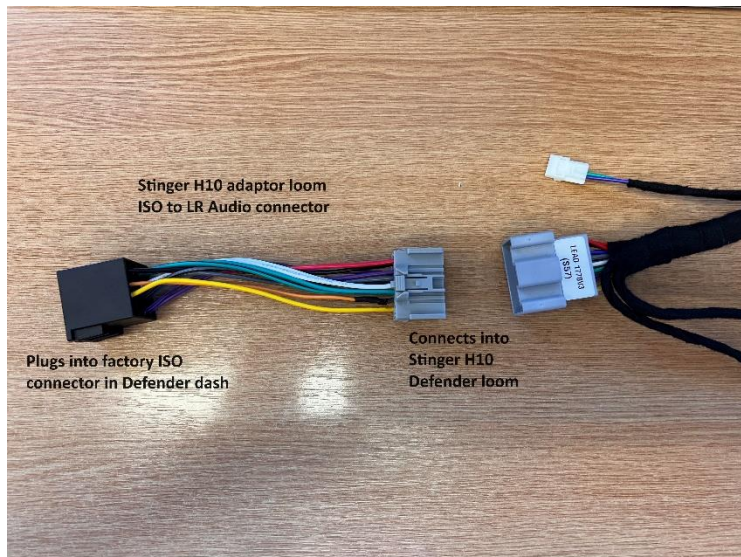
If your Defender uses factory ISO audio connections you will need to use the additional ISO adaptor harness included (pictured below) within the Heigh10 kit to convert the factory ISO connector to the large grey 'Puma' connector found on the H10 OBD/Binnacle harness.

On later model Defenders that use the large grey audio connector you DO NOT need to use the additional ISO adaptor harness included (pictured above) within the H10 kit. The large grey connector on the OBD/Binnacle harness will connect directly into the OE grey audio connector in the dashboard.

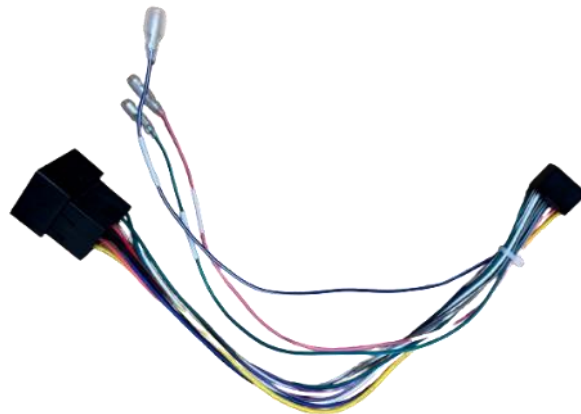
For earlier factory ISO equipped cars you can connect the head unit into the factory ISO connection using the shorter head-unit ISO loom supplied with the H10 kit and the separate camera/sub-woofer input harness (if required).

On post 2012 cars you should retain your original ISO adaptor and use the shorter head-unit loom that connects into the back of the H10 and the separate camera/sub-woofer input harness (if required).

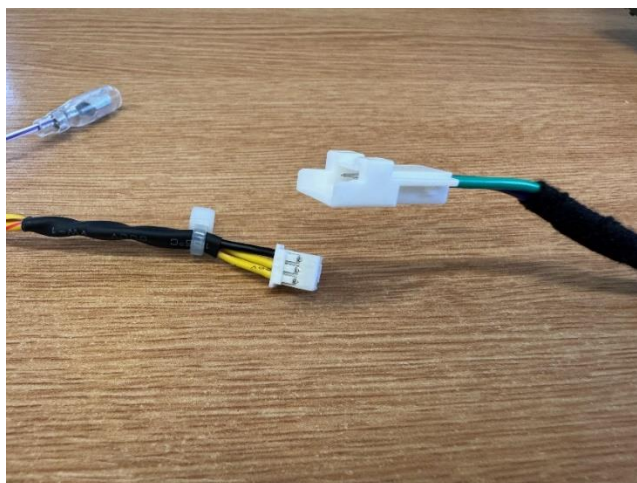
The 'Vehicle Info' icon on the screen will only appear if the link harness is connected as this provides the electronic link between the H10 and the OBD/instrument binnacle. The respective connectors on the PAC Link harness don't look like they connect together & the wire colours on the respective connectors are not the same. We **REPEATEDLY** see these incorrectly connected or not connected at all.

The PAC Link connectors can sometimes pull apart when the unit is being installed because everything is so tight for room behind the Defender dashboard. We recommend taping this connection together. This is usually the reason no Vehicle Info is displaying on the H10.

Check the connections of the PAC Link harness, as per Step 3 on the Connection Diagram on the Resources section on the Heigh10 page at www.mudstuff.co.uk

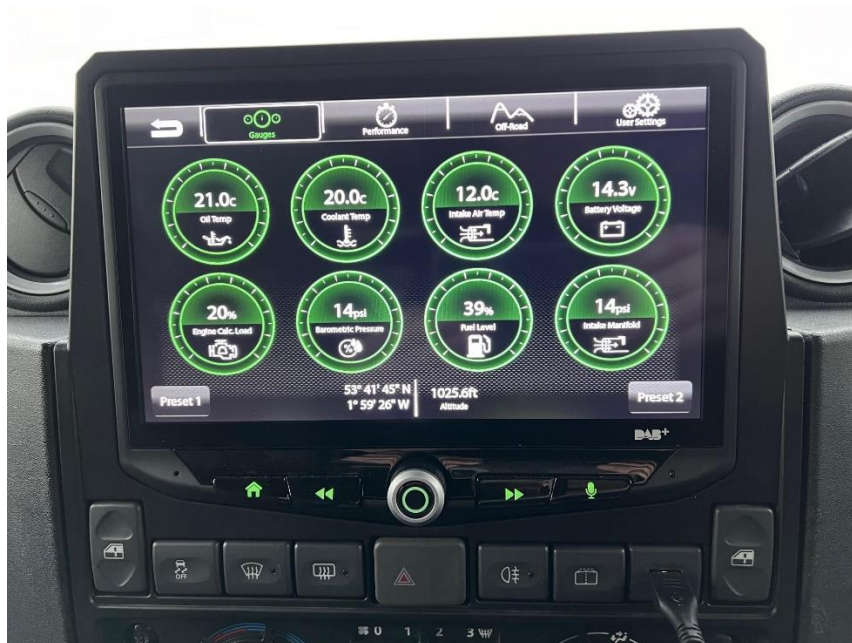
On the earlier 2.4Tdc engines some of the OBD info (e.g. oil temp) is unable to be displayed on the Heigh10.

This is a limitation of the vehicles network outputs. The older 2.4Tdc uses an old-fashioned mechanical method of output that cannot be fed into the head unit unlike its newer platform (2.2Tdc) equivalent.
