Dell PowerVault ME4 Series Storage System

Owner's Manual

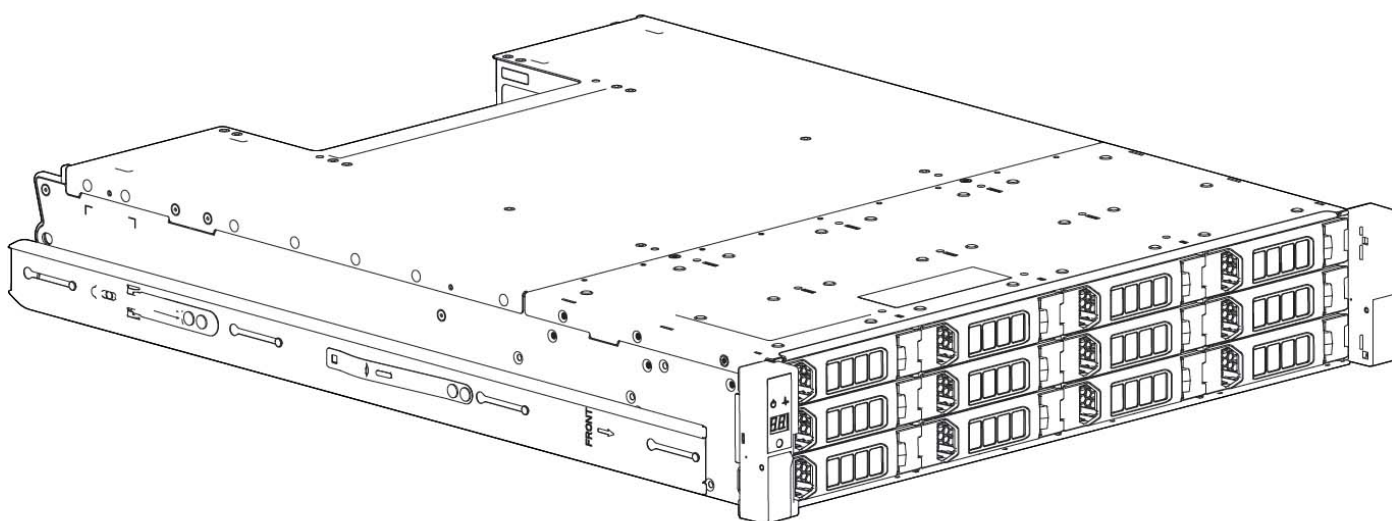
Figure 1. 2U12 enclosure system—front orientation

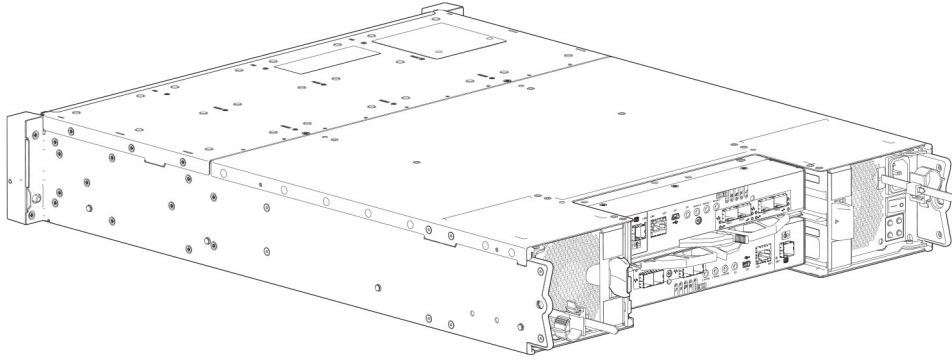
The 2U12 controller enclosure is equipped with dual-controllers.

Figure 2. 2U12 enclosure system—rear orientation

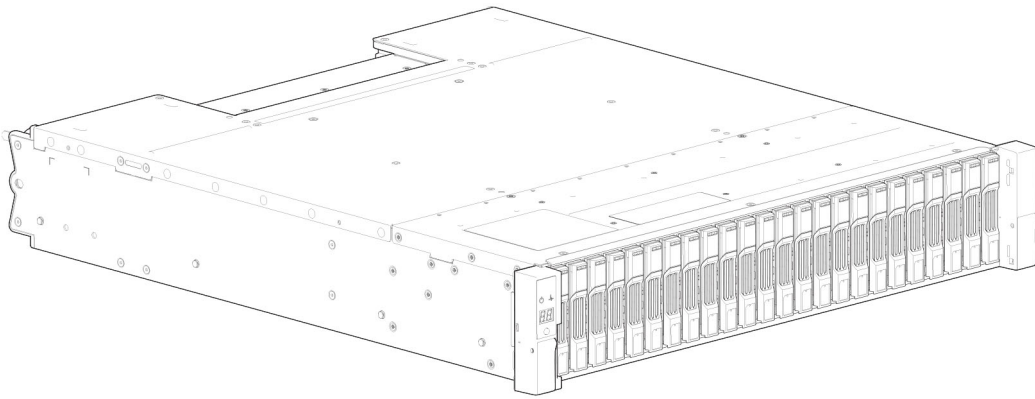
Figure 3. 2U24 enclosure system—front orientation

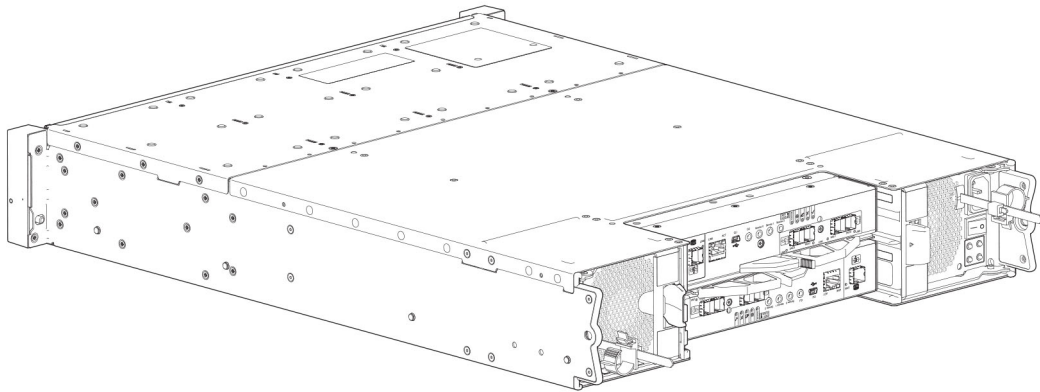
The 2U24 controller enclosure is equipped with dual-controllers.

Figure 4. 2U24 enclosure system—rear orientation

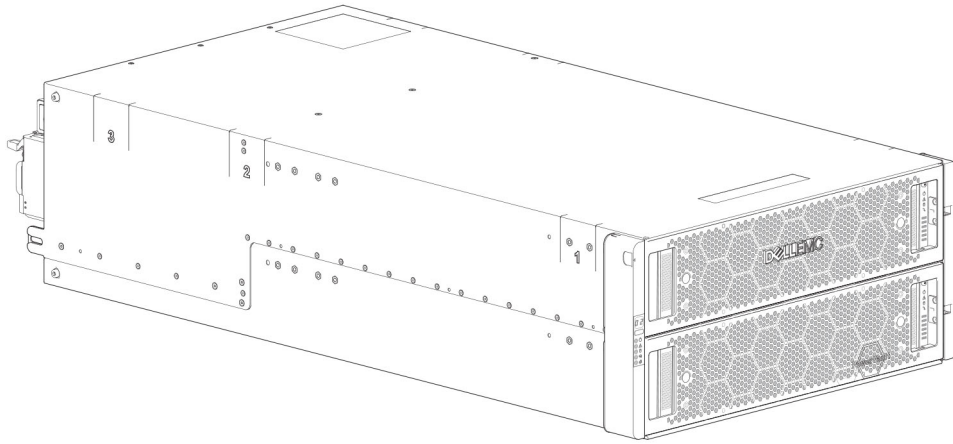
Figure 5. 5U84 enclosure system—front orientation

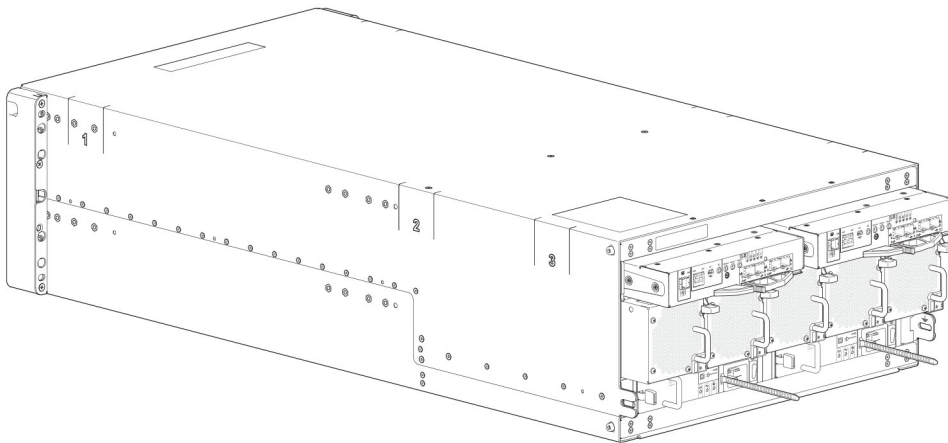
The 5U84 controller enclosure is equipped with dual-controllers.

Figure 6. 5U84 enclosure system—rear orientation

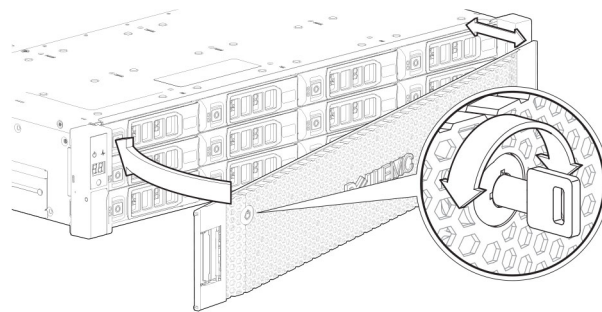
The following figure shows a partial view of a 2U12 enclosure:

Figure 7. Attaching or removing the 2U enclosure front bezel

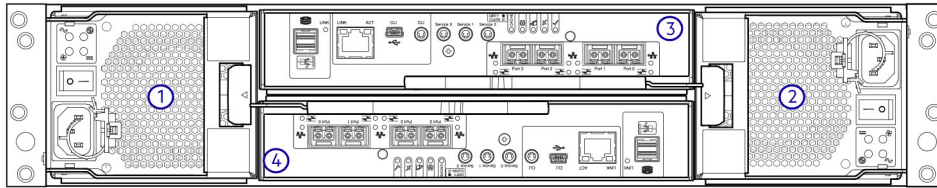
Alphabetic designators on controller modules or IOMs and numeric designators on PCMs indicate slot sequencing for the modules used in 2U enclosures. Controller modules, IOMs, and PCMs are available as CRUs. The ME4 Series RBODs use 4-port controller modules. These RBODs support the ME412/ME424/ME484 EBODs for optionally adding storage.

Figure 10. 2U controller enclosure—rear panel components (4-port FC/iSCSI)

| 1. Power cooling module slot 0 | 2. Power cooling module slot 1 |
| 3. Controller module slot A | 4. Controller module slot B |

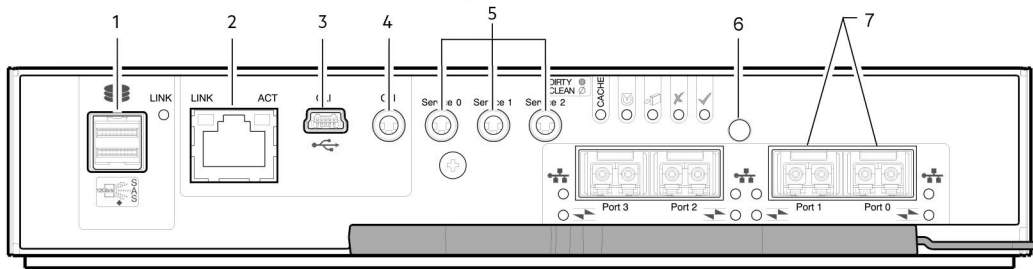
The Converged Network Controller (CNC) ports on the 4-port FC/iSCSI controller module can be configured with 16Gb/s FC SFPs or 10 GbE iSCSI SFPs.

Figure 14. 4-port FC/iSCSI controller module detail

| 7. CNC ports (ports 3, 2, 1, 0) | |

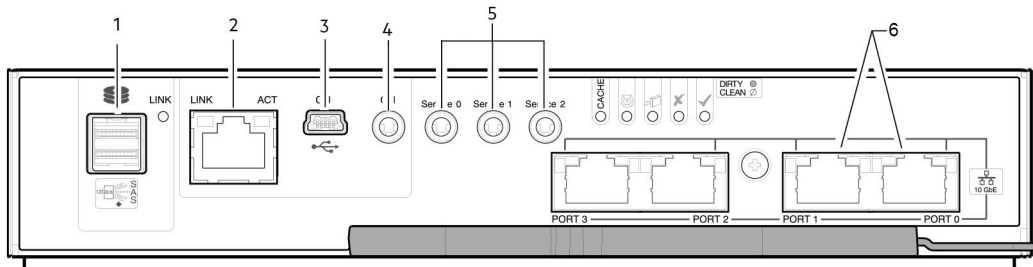
The following figure shows iSCSI 10Gbase-T host interface ports that ship configured with pre-installed external connectors.

Figure 15. 4-port iSCSI 10Gbase-T controller module detail

| 5. 3.5 mm serial ports (service only) | 6. 10Gbase-T ports (ports 3, 2, 1, 0) |

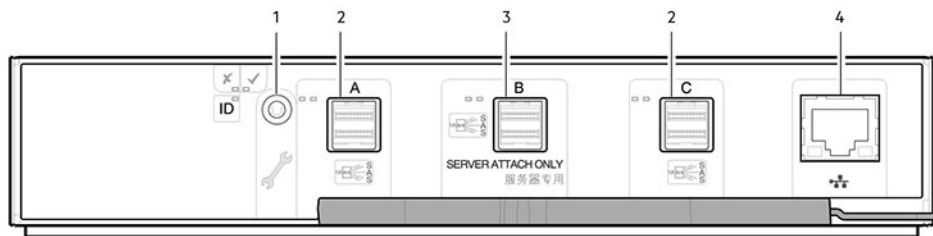
The following figure shows the IOM used in supported expansion enclosures for adding storage. Ports A/B/C ship configured with 12 Gb/s mini-SAS HD (SFF-8644) external connectors.

Figure 17. IOM detail – ME412/ME424/ME484

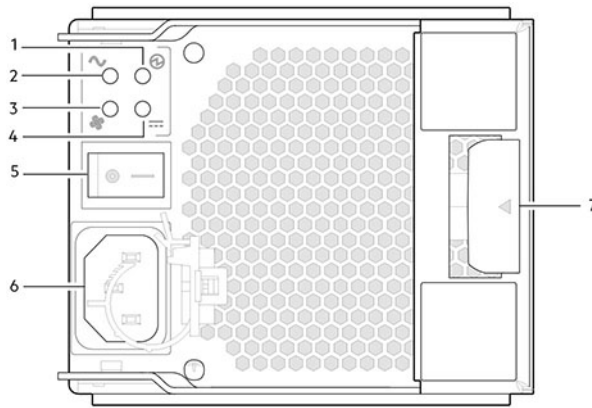
The following figure shows the power cooling module (PCM) used in controller enclosures and optional expansion enclosures. The PCM includes integrated cooling fans. The example shows a PCM oriented for use in the left PCM slot of the enclosure rear panel.

Figure 18. Power cooling module (PCM)

| 1. PCM OK LED (Green) | 2. AC Fail LED (Amber/blinking amber) |
| 3. Fan Fail LED (Amber/blinking amber) | 4. DC Fail LED (Amber/blinking amber) |

- If any of the PCM LEDs are illuminated amber, a module fault condition or failure has occurred.
- For a detailed description of PCM LED behavior, see [2U enclosure LEDs](#) on page 33.

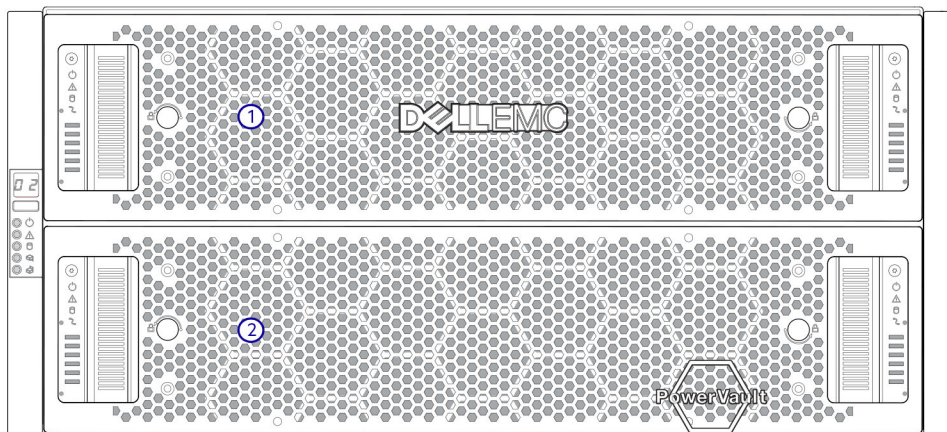
Figure 19. 5U84 enclosure—front panel components

1. 5U84 enclosure drawer (slot 0 = top drawer)

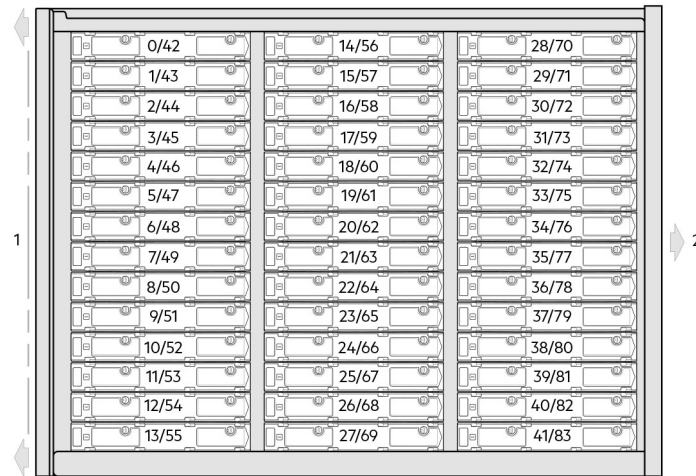
This figure shows a plan view of an enclosure drawer that is accessed from the enclosure front panel. The conceptual graphics are simplified for clarity.

Figure 20. 5U84 enclosure system - plan view of drawer accessed from front panel

- 1. Drawer front panel (shown as an edge in plan view)
- 2. Direction into the enclosure drawer slot (slot 0 or 1)

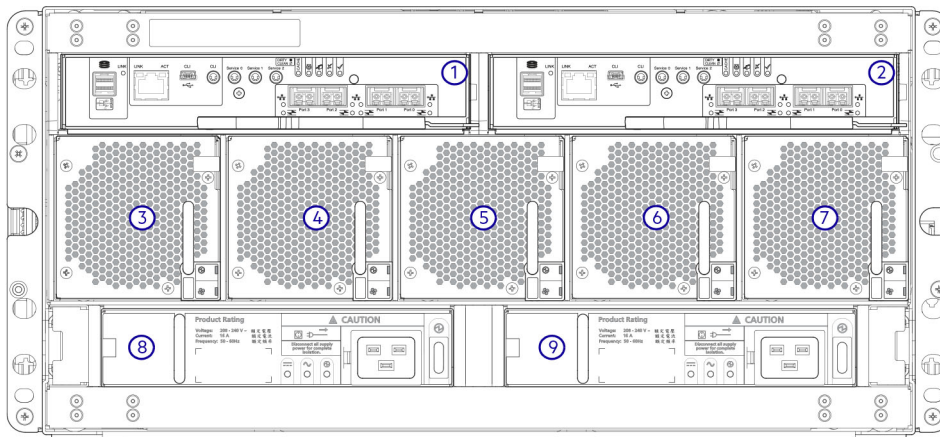
Alphabetic designators on controller modules and IOMs, and numeric designators on PSUs (Power Supply Units) and FCMs (Fan Control Modules) indicate slot sequencing for modules used in 5U84 enclosures. Controller modules, IOMs, PSUs, and FCMs are available as CRUs.

Figure 21. 5U84 controller enclosure—rear panel components (4-port FC/iSCSI)

- 1. Controller module slot A
- 2. Controller module slot B
- 3. FCM slot 0
- 4. FCM slot 1
- 5. FCM slot 2
- 6. FCM slot 3
- 7. FCM slot 4
- 8. PSU slot 0
- 9. PSU slot 1

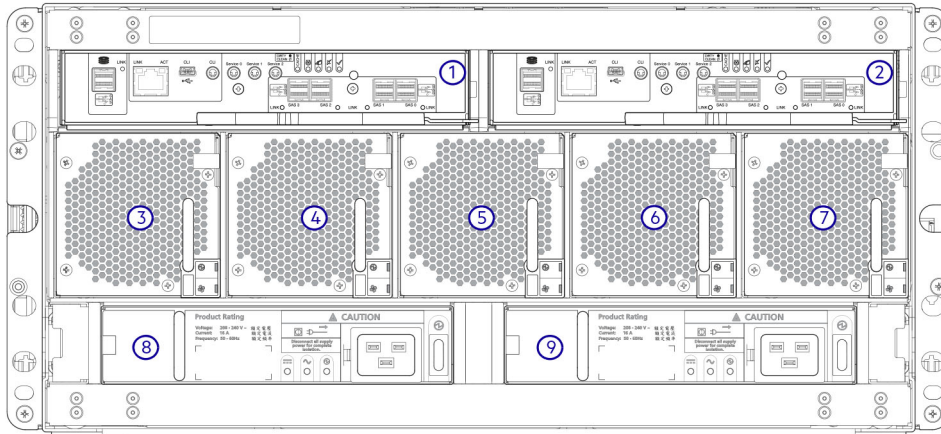
Figure 22. 5U84 controller enclosure—rear panel components (4-port SAS)

| 7. FCM slot 4 | 8. PSU slot 0 |
| 9. PSU slot 1 | |

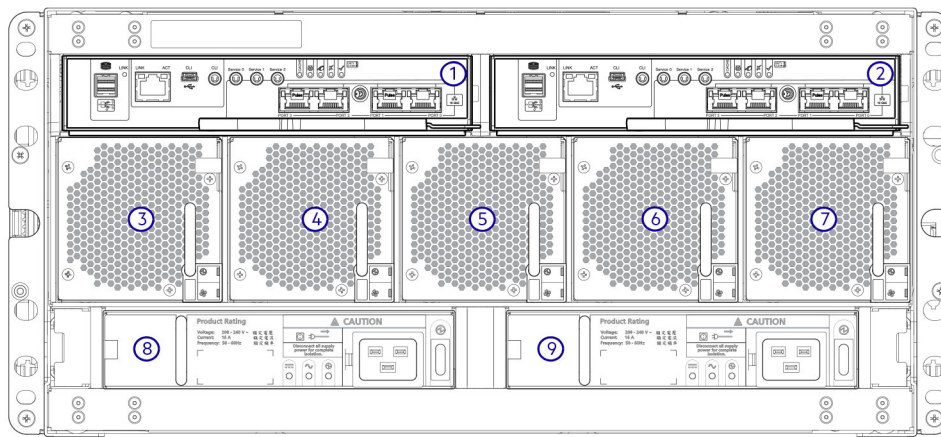
Figure 23. 5U84 controller enclosure—rear panel components (4-port iSCSI 10Gbase-T)

| 7. FCM slot 4 | 8. PSU slot 0 |
| 9. PSU slot 1 | |

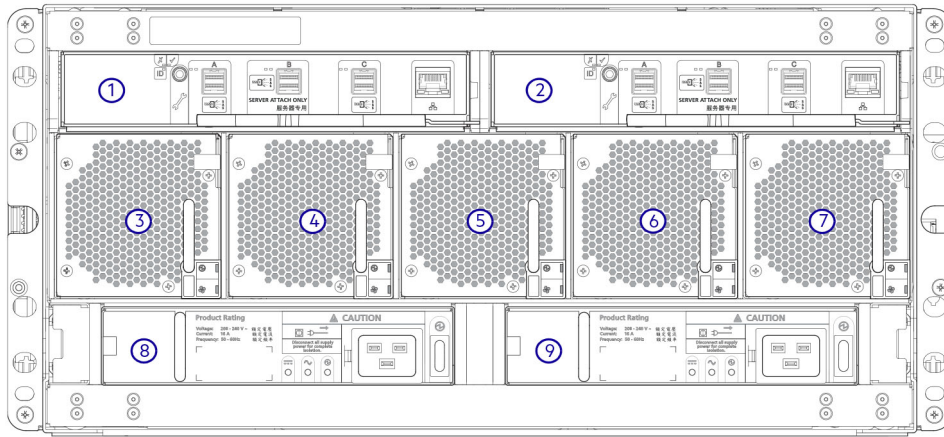
Figure 24. 5U84 expansion enclosure—rear panel components

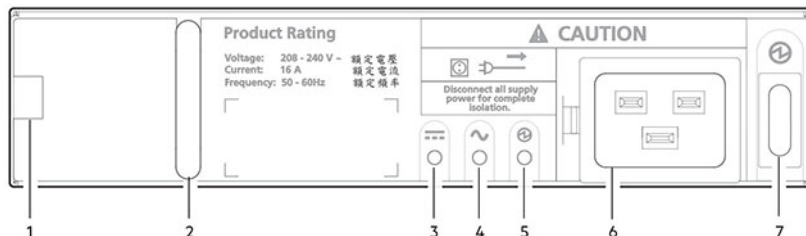
This figure shows the power supply unit that is used in 5U controller enclosures and optional 5U84 expansion enclosures.

Figure 25. Power supply unit (PSU)

| 3. PSU Fault LED (Amber/blinking amber) | 4. AC Fail LED (Amber/blinking amber) |

- If any of the PSU LEDs are illuminated amber, a module fault condition or failure has occurred.
- For a detailed description of PSU LEDs, see [FCM LED states](#) on page 36.

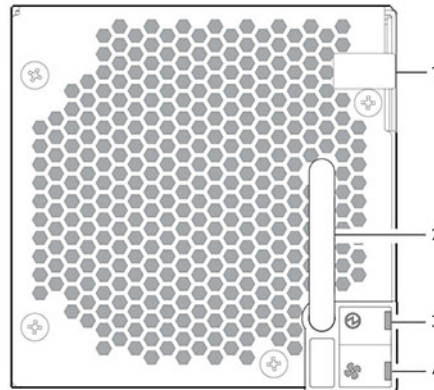
The following figure shows the fan cooling module (FCM) used in 5U controller enclosures and optional 5U expansion enclosures.

Figure 26. Fan cooling module (FCM)

- If any of the FCM LEDs are illuminated amber, a module fault condition or failure has occurred..
- For a detailed description of FCM LEDs, see [5U84 enclosure FCM LEDs](#) on page 36.

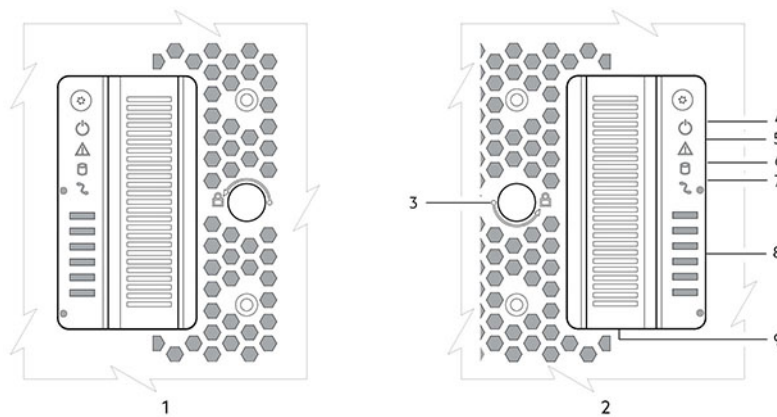
Each drawer can be locked shut by turning both anti-tamper locks clockwise using a screwdriver with a Torx T20 bit (included in your shipment). The anti-tamper locks are symmetrically placed on the left and right sides of the drawer bezel. Drawer status and activity LEDs can be monitored by two drawer LEDs panels located next to the two drawer-pull pockets located on the left and right side of each drawer.

Figure 27. Drawer bezel details

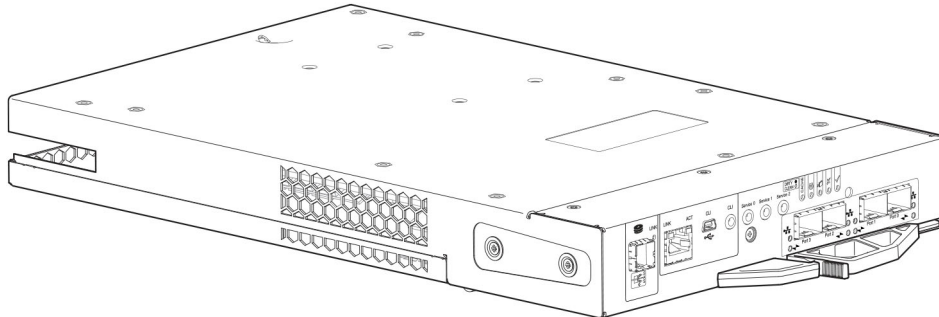
The following figure shows a 4-port FC/iSCSI controller module aligned for use in the top slot located on the 2U enclosure rear panel. The controller module is also properly aligned for use in either slot located on the 5U84 enclosure rear panel.

Figure 30. Controller module – rear orientation

Each controller module maintains VPD (Vital Product Data) in EEPROM devices. In a dual-controller module system, controller modules are interconnected by SBB-defined I2C buses on the midplane. In this way, the SBB module can discover the type and capabilities of the partner SBB module, and vice versa, within the enclosure.

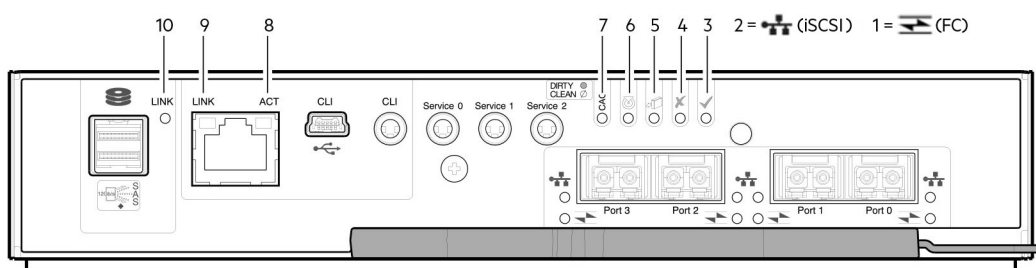
Figure 31. ME4 Series Storage System FC/iSCSI controller modules (FC and 10GbE SFPs) LEDs

⁴Cache Status LED supports power on behavior and operational (cache status) behavior. See also [Cache Status LED – power on behavior](#) on page 27.

⁵When port is down, both LEDs are off.

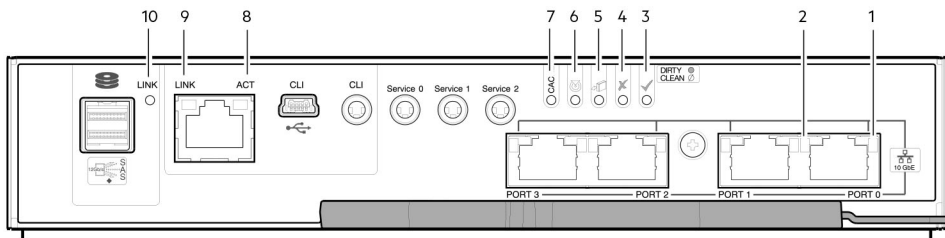
Figure 32. ME4 Series 10Gbase-T controller module LEDs

6	Identify	White—The controller module is being identified.
7	Cache status ³	<ul style="list-style-type: none"> Green—Cache is dirty (contains unwritten data) and operation is normal. The unwritten information can be log or debug data that remains in the cache, so a green cache status LED does not, by itself, indicate that any user data is at risk or that any action is necessary. Off—In a working controller, cache is clean (contains no unwritten data). This is an occasional condition that occurs while the system is booting. Blinking green—A CompactFlash flush or cache self-refresh is in progress, indicating cache activity.
8	Network Port Activity Status ⁴	<ul style="list-style-type: none"> Off—The Ethernet link is not established, or the link is down. Green—The Ethernet link is up (applies to all negotiated link speeds).
9	Network Port Link Speed ⁴	<ul style="list-style-type: none"> Off—Link is up at 10/100base-T negotiated speeds. Amber—Link is up and negotiated at 1000base-T.

³Cache Status LED supports power on behavior and operational (cache status) behavior.

⁴When port is down, both LEDs are off. See also [Cache Status LED – power on behavior](#) on page 27.

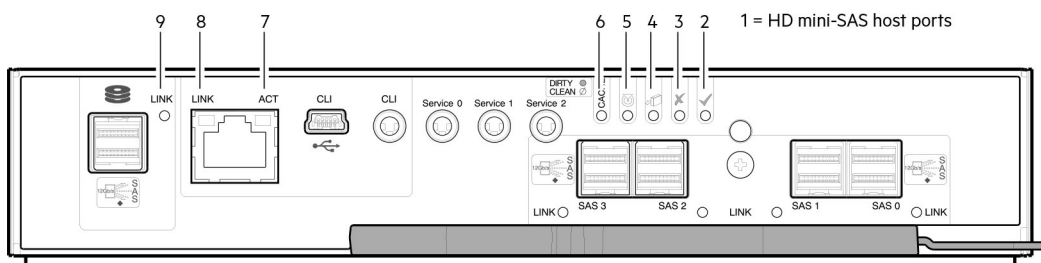
Figure 33. ME4 Series SAS controller module LEDs

6	Cache status ³	<ul style="list-style-type: none"> Green—Cache is dirty (contains unwritten data) and operation is normal. The unwritten information can be log or debug data that remains in the cache, so a green cache status LED does not, by itself, indicate that any user data is at risk or that any action is necessary. Off—In a working controller, cache is clean (contains no unwritten data). This is an occasional condition that occurs while the system is booting. Blinking green—A CompactFlash flush or cache self-refresh is in progress, indicating cache activity.
7	Network Port Activity Status ⁴	<ul style="list-style-type: none"> Off—The Ethernet link is not established, or the link is down. Green—The Ethernet link is up (applies to all negotiated link speeds).
8	Network Port Link Speed ⁴	<ul style="list-style-type: none"> Off—Link is up at 10/100base-T negotiated speeds. Amber — Link is up and negotiated at 1000base-T.

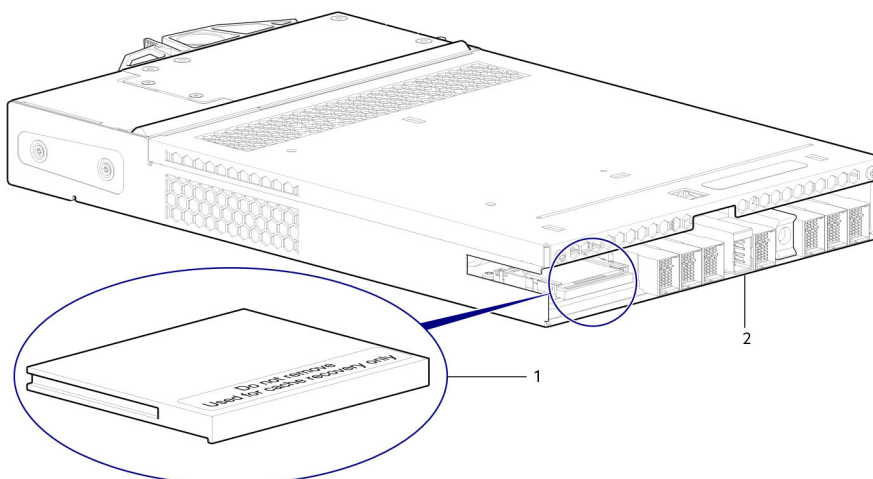
During a power loss or controller failure, data stored in cache is saved off to non-volatile memory (CompactFlash). The data is restored to cache, and then written to disk after the issue is corrected. To protect against writing incomplete data to disk, the image stored on the CompactFlash is verified before committing to disk. The CompactFlash memory card is located at the midplane-facing end of the controller module. Do not remove the card; it is used for cache recovery only.

Figure 34. CompactFlash memory card

1. CompactFlash memory card
2. Controller module viewed from back

In single-controller module configurations, if the controller module has failed or does not start, and the Cache Status LED is on or blinking, the CompactFlash needs to be transported to a replacement controller to recover data not flushed to the disk.

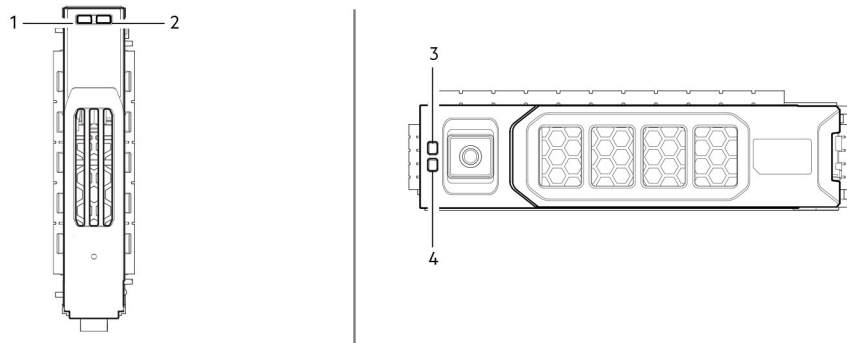
The drive module LEDs are identified in the figure, and the LED behavior is described in the table following the figure.

- In normal operation, the green LED are on, and flicker as the drive operates.
- In normal operation the amber LED will be:
 - Off if there is no drive present.
 - Off as the drive operates.
 - On if there is a drive fault.

Figure 35. LEDs: Drive carrier LEDs (SFF and LFF modules) used in 2U enclosures

- 1. Disk Activity LED
- 2. Disk Fault LED
- 3. Disk Fault LED
- 4. Disk Activity LED

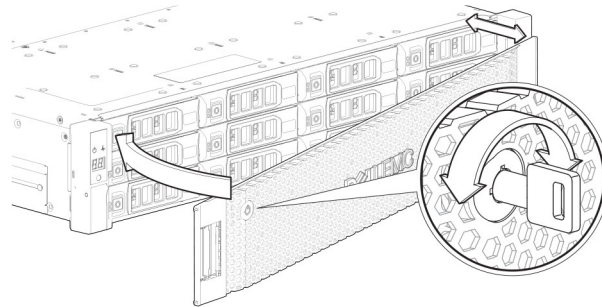
The following figure shows a partial view of a 2U12 enclosure:

Figure 37. Attaching or removing the 2U enclosure front bezel

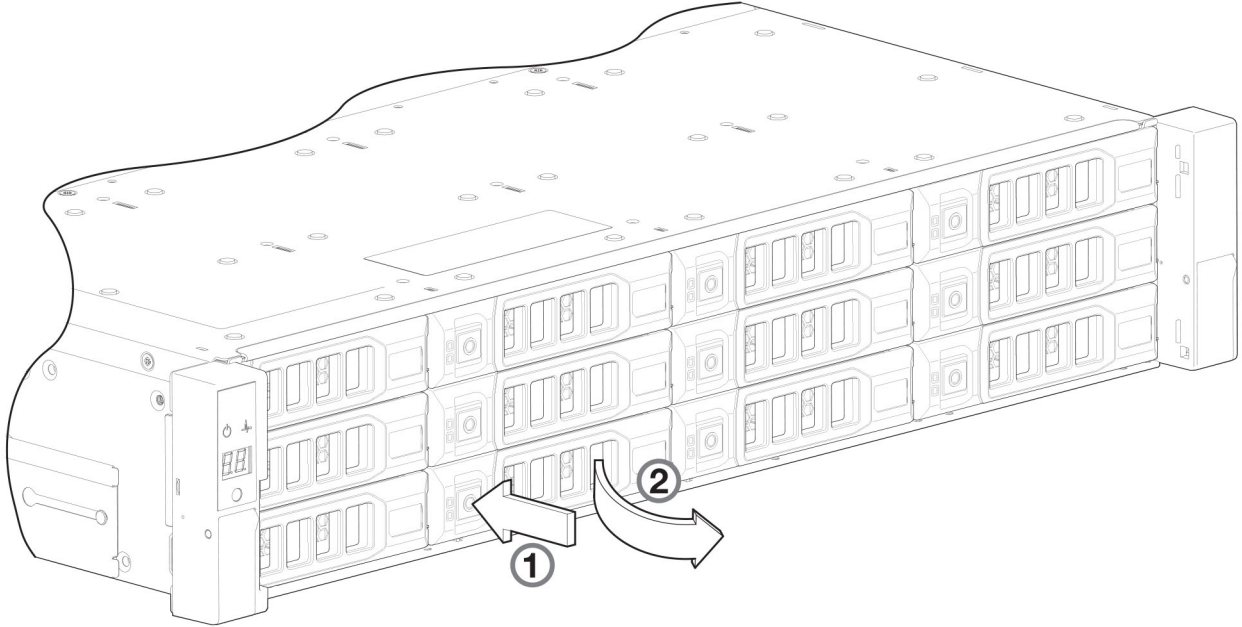
1. Press the latch on the drive module carrier to open the handle.

Figure 38. Removing an LFF drive carrier module (1 of 2)

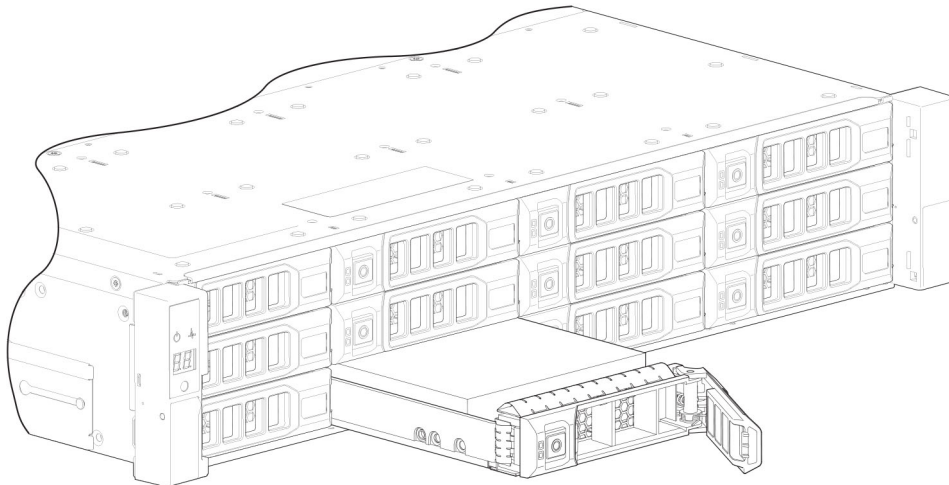
2. Gently move the drive carrier module approximately 25 mm (1 in.), and then wait 30 seconds for the drive to spin down.

Figure 39. Removing an LFF drive carrier module (2 of 2)

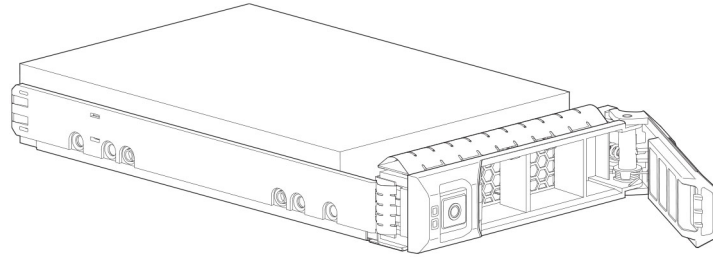
1. Press the latch on the drive module carrier to open the handle.

Figure 40. LFF drive carrier module in open position

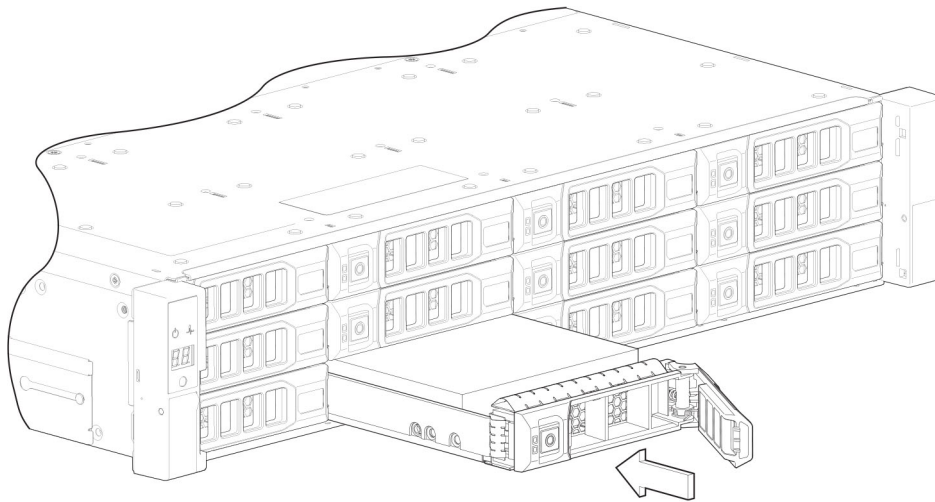
2. Insert the drive carrier module into the enclosure.
3. Gently slide the drive carrier module into the enclosure until it stops moving.

Figure 41. Installing an LFF drive carrier module (1 of 2)

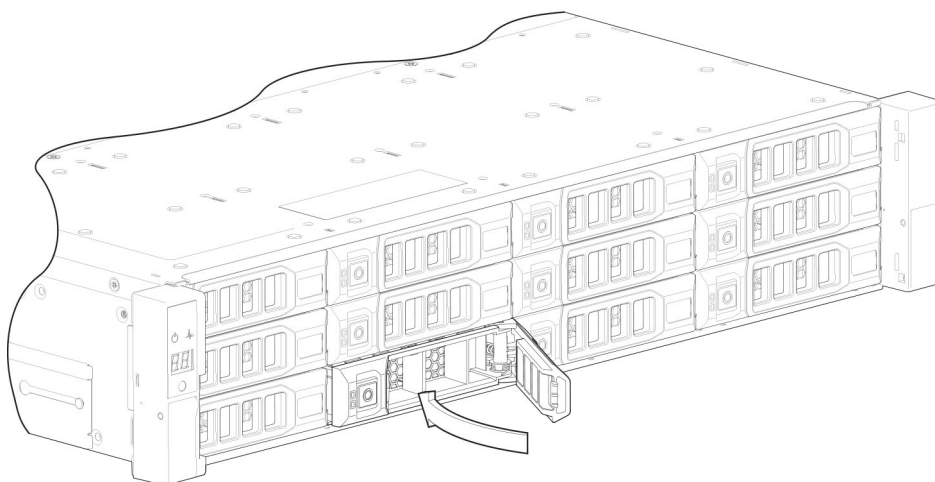
4. Push the drive carrier module further into the enclosure until the latch handle starts to engage.
5. Continue to push firmly until the latch handle fully engages. You should hear a click as the latch handle engages and holds the handle closed.

Figure 42. Installing an LFF drive carrier module (2 of 2)

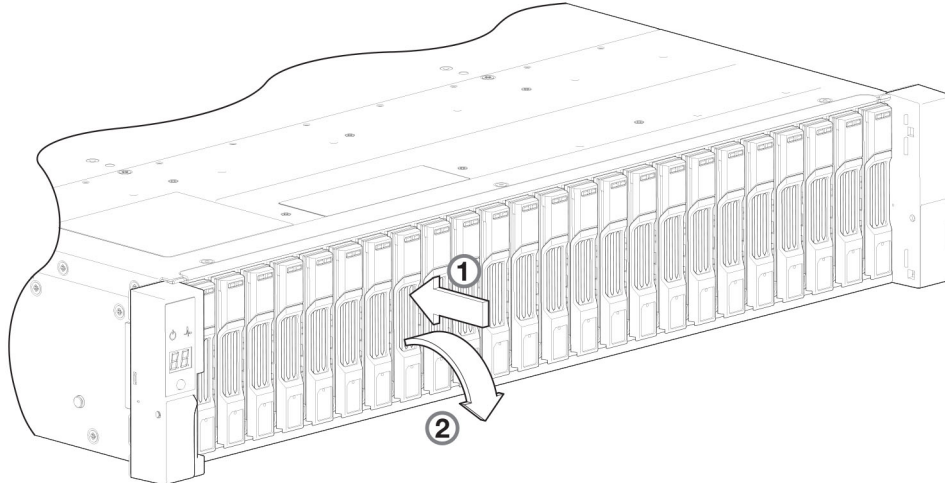
1. Press the latch on the drive module carrier to open the handle.

Figure 43. Removing an SFF drive module carrier (1 of 2)

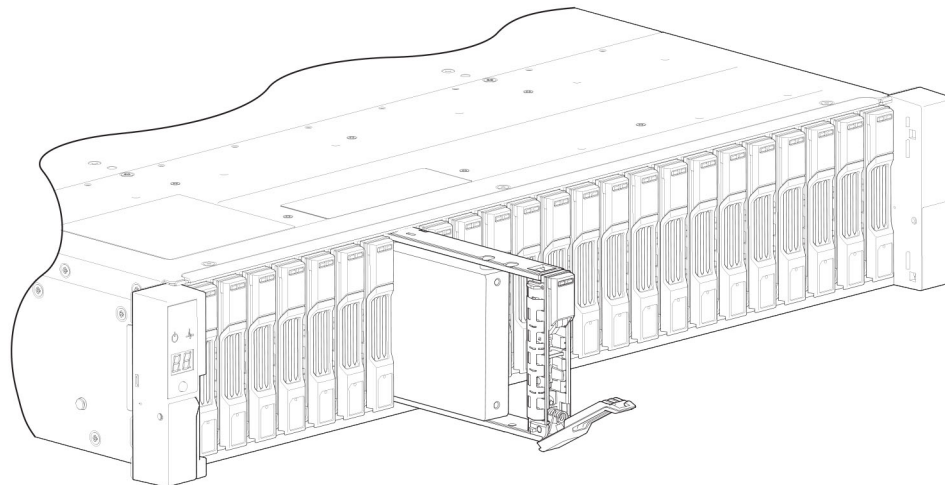
2. Gently move the drive carrier module approximately 25 mm (1 in.), and then wait 30 seconds for the drive to spin down.

Figure 44. Removing an SFF drive module carrier (2 of 2)

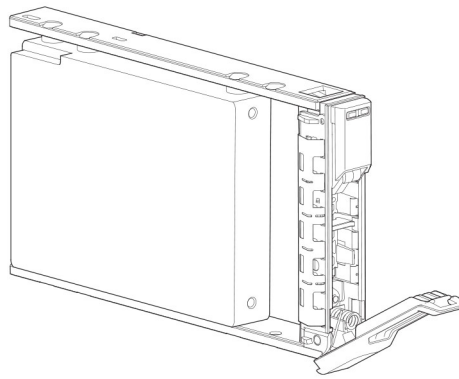
1. Press the latch on the drive module carrier to open the handle.

Figure 45. SFF drive carrier module in open position

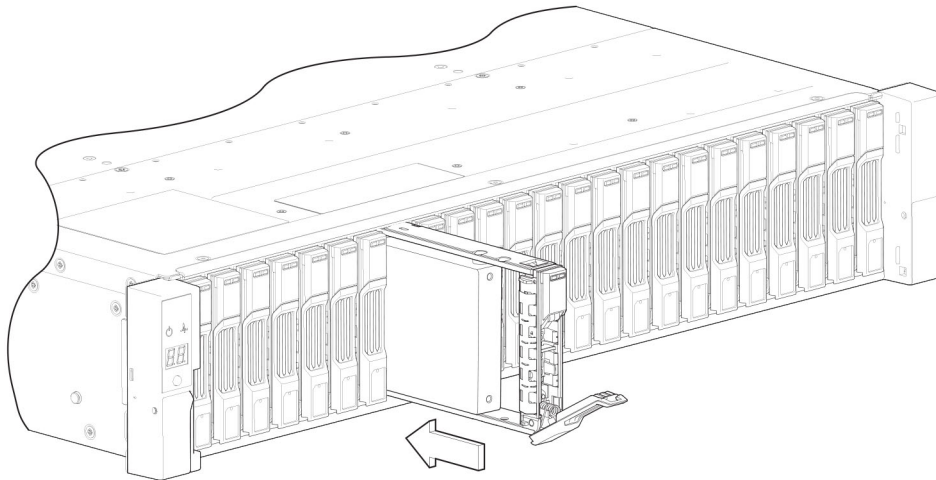
Figure 46. Installing an SFF drive carrier module (1 of 2)

2. Insert the drive carrier module into the enclosure.
3. Gently slide the drive carrier module into the enclosure until it stops moving.

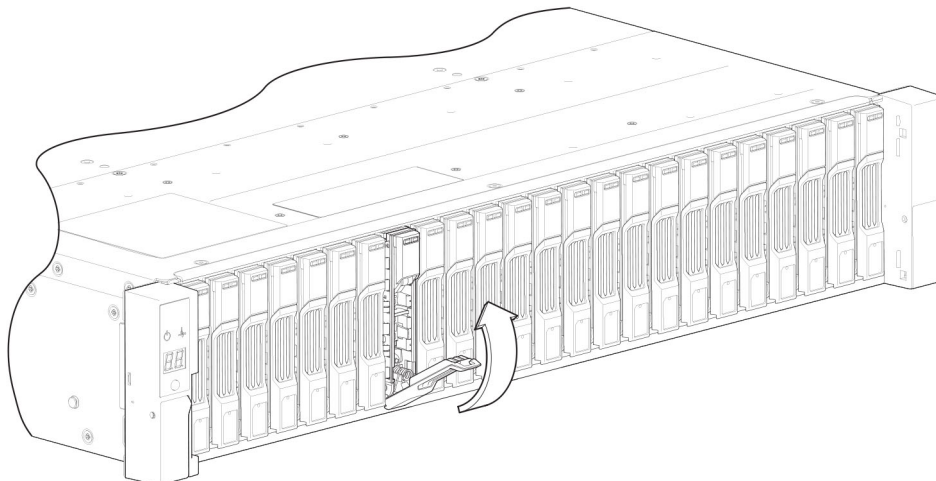
Figure 47. Installing an SFF drive carrier module (2 of 2)

4. Push the drive carrier module further into the enclosure until the latch handle starts to engage.
5. Continue to push firmly until the latch handle fully engages. You should hear a click as the latch handle engages and holds the handle closed.

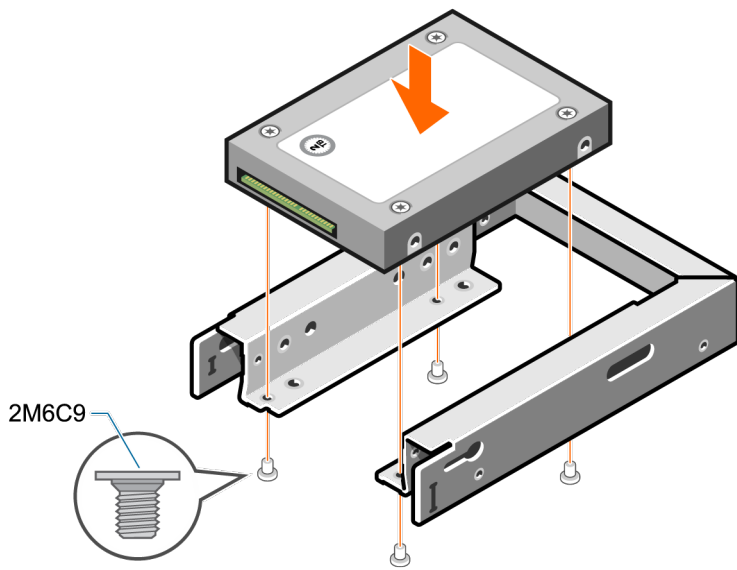
1. Install the 2.5" replacement disk drive into the 3.5" mounting bracket.

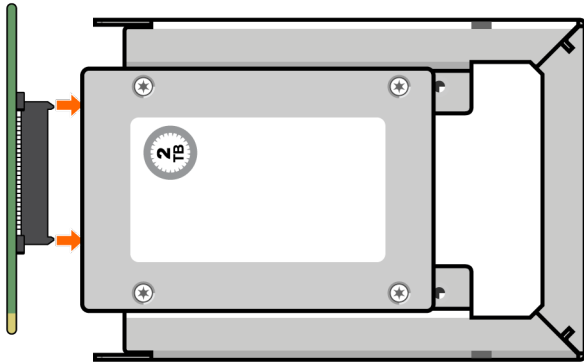
2. Insert the SAS connector into the SAS interface on the disk drive.

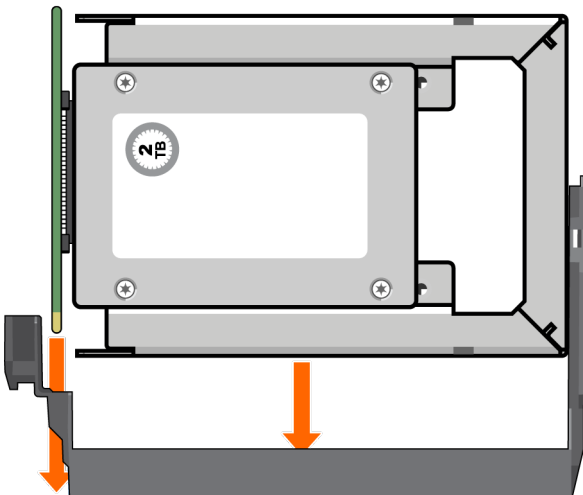
3. Insert the 3.5" mounting bracket with the 2.5" disk drive into the lower assembly.

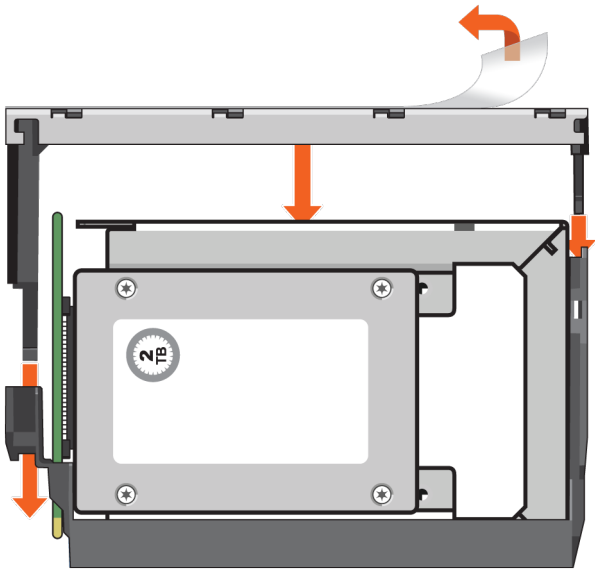
4. Remove the protective film from the upper assembly of the DDIC.
5. Slide the upper assembly of the DDIC onto the mounting bracket with the 2.5" disk drive

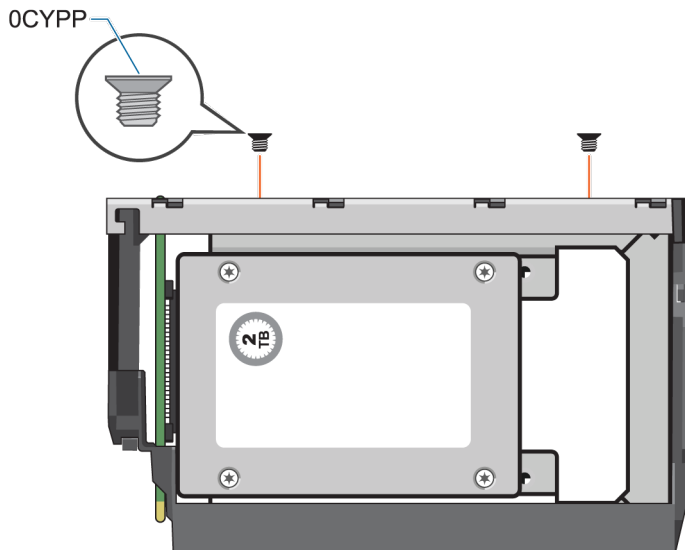
6. Secure the upper assembly to the mounting bracket using the supplied screws.

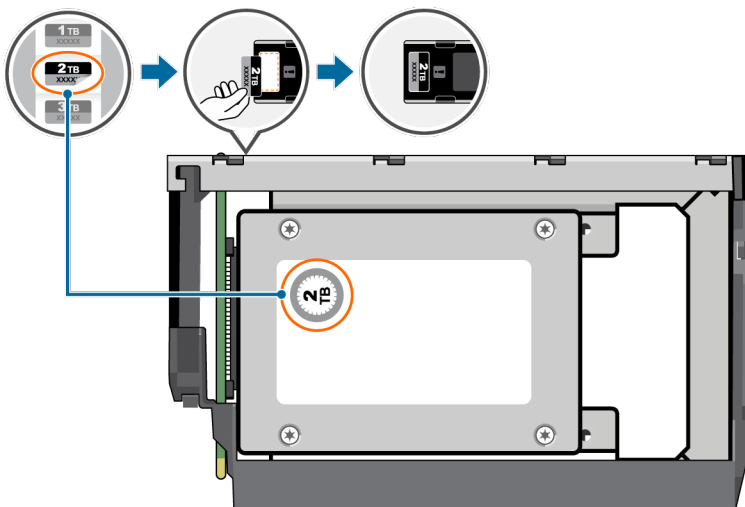
7. Attach the appropriate drive size label to the label location on top of the upper assembly.

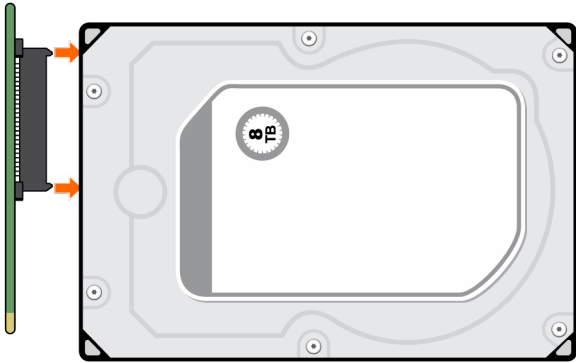
1. Insert the SAS connector into the SAS interface on the disk drive.

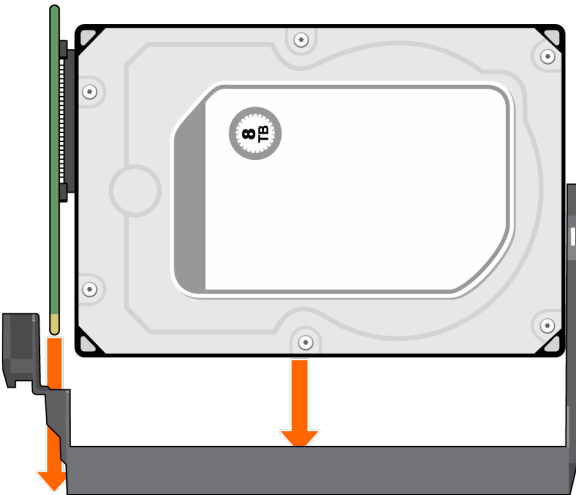
2. Slide the disk drive into the lower assembly of the DDIC.

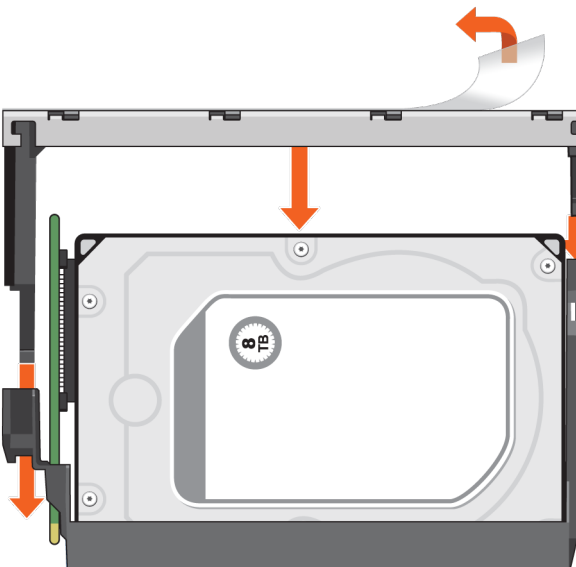
3. Remove the protective film from the upper assembly of the DDIC.
4. Slide the upper assembly of the DDIC onto the disk drive.

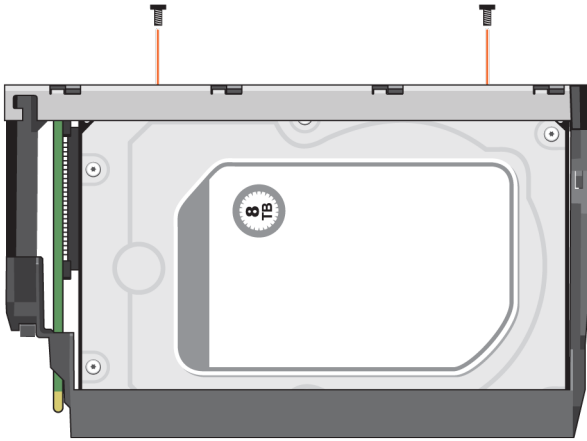
- Secure the upper assembly to the disk drive using the supplied screws.

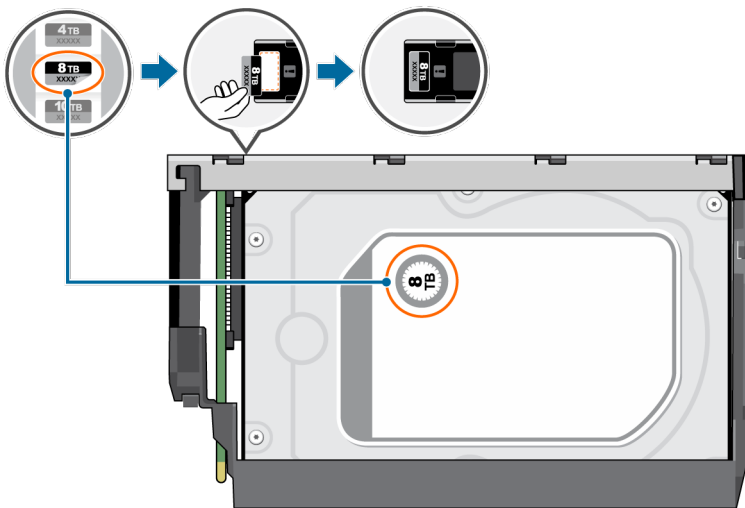
- Attach the appropriate drive size label to the label location on top of the upper assembly.

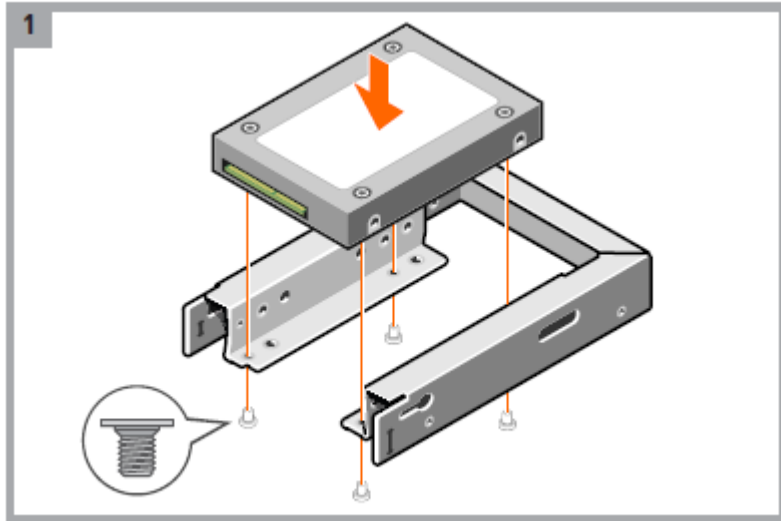
- Install the 2.5" replacement disk drive into the 3.5" adapter.

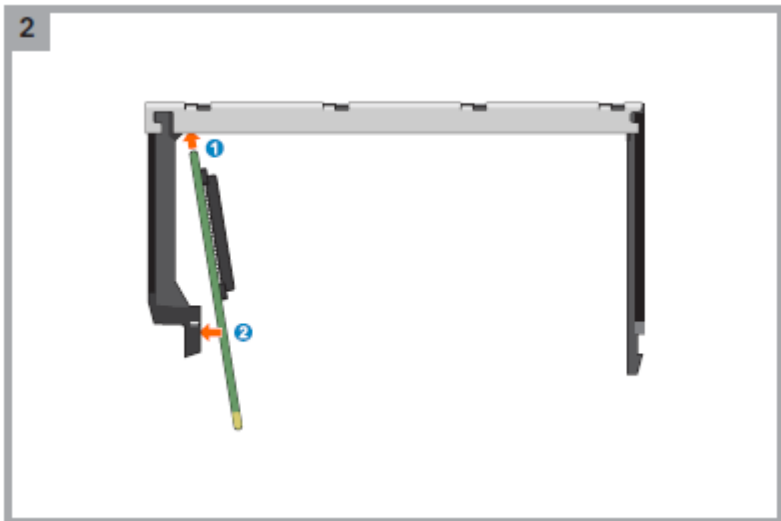
2. Insert the SAS connector into the new DDIC.

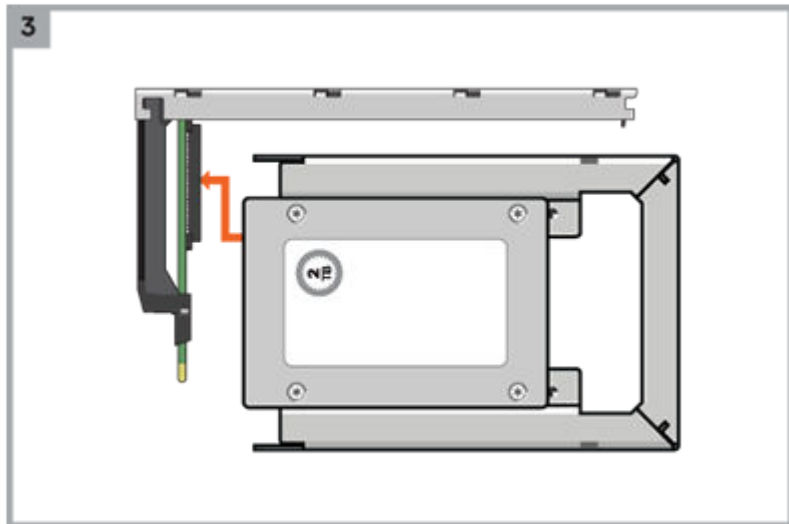
3. Insert the 3.5" adapter with the 2.5" disk drive into the new DDIC and connect the disk drive to the SAS connector.

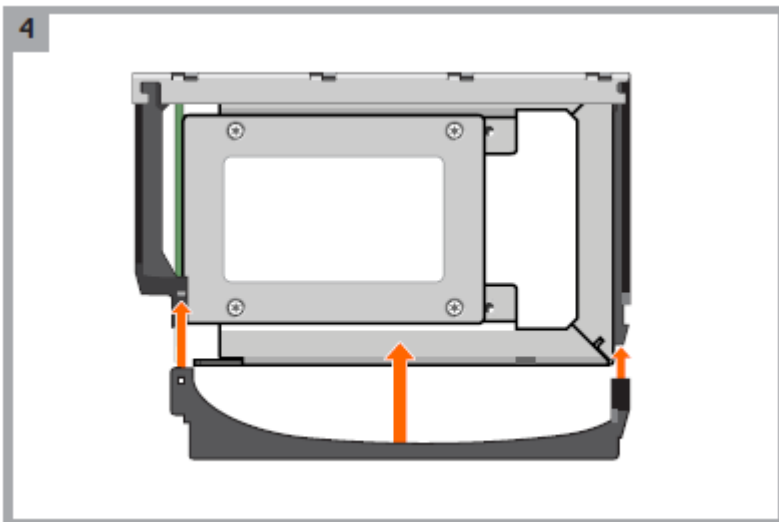
4. Attach the bottom bracket to the new DDIC.

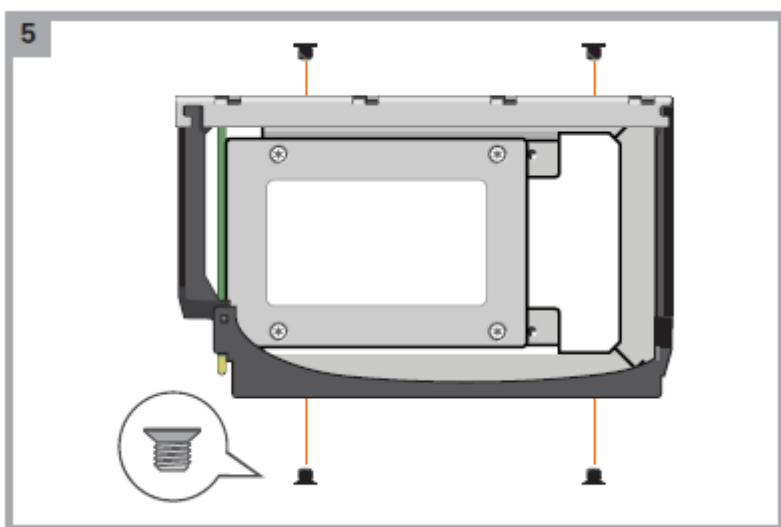
5. Secure the disk drive in the new DDIC using the four screws shipped with the new DDIC.

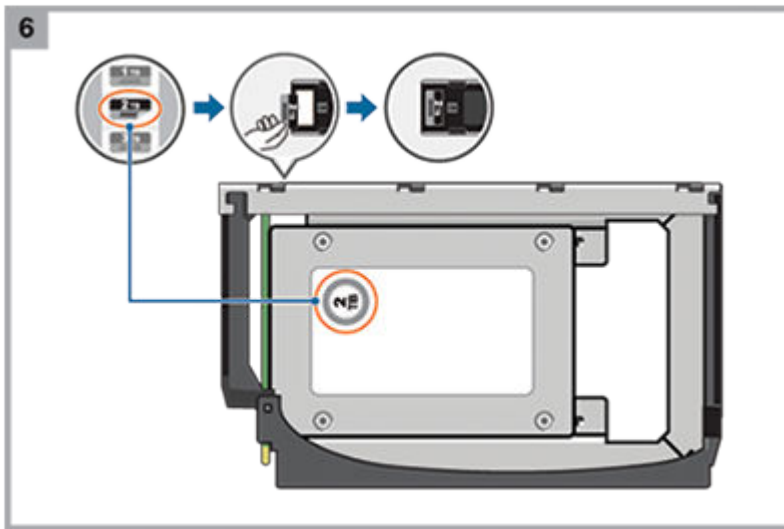
6. Attach the appropriate disk drive size label to the new DDIC.
