Dell PowerVault ME4 Series Storage System

Owner's Manual

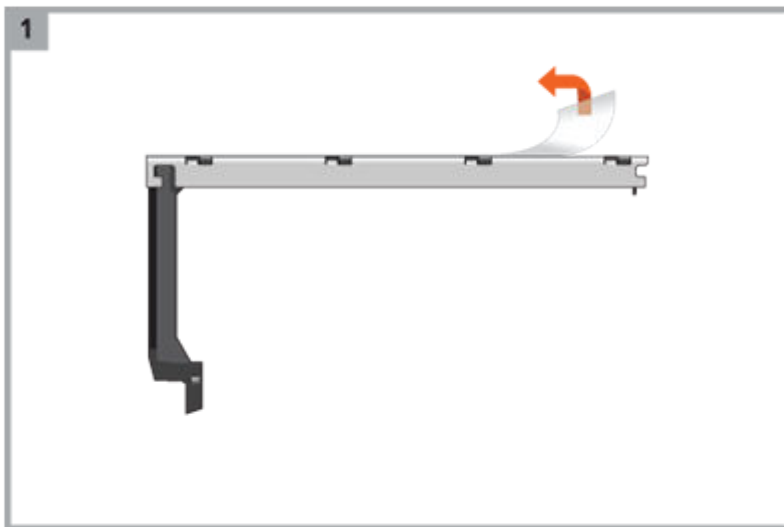
1. Remove the protective plastic from the new DDIC.

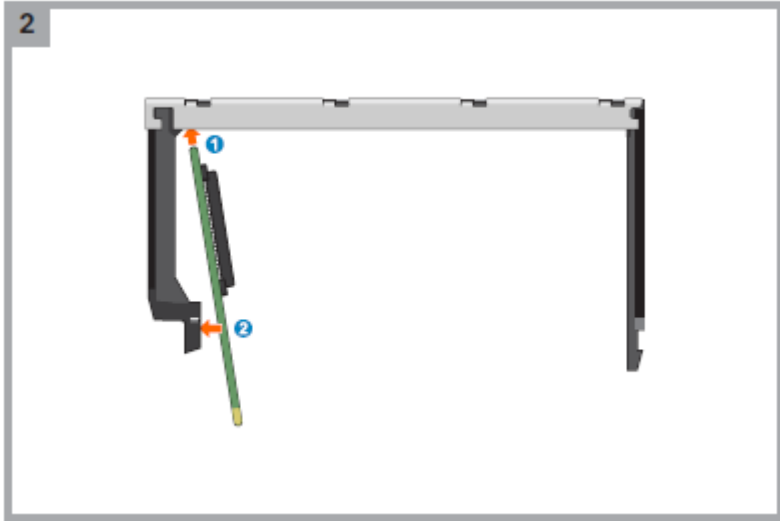
2. Insert the SAS connector into the new DDIC.

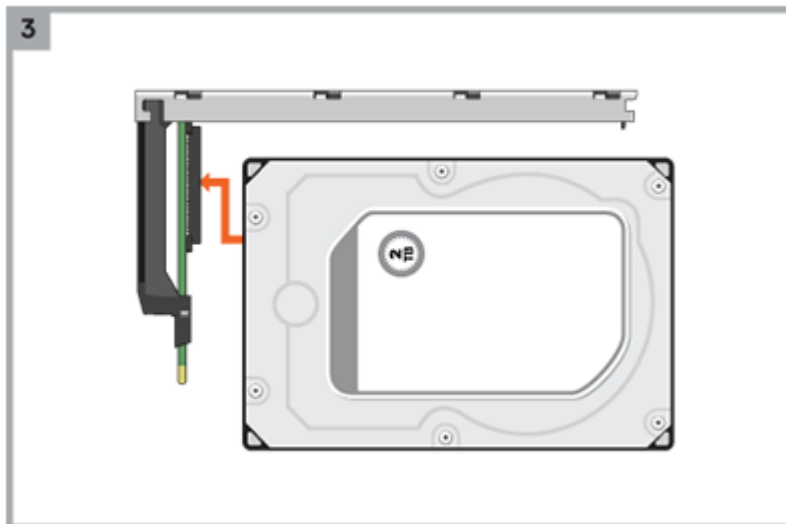
3. Insert the disk drive into the new DDIC and connect the disk drive to the SAS connector. .

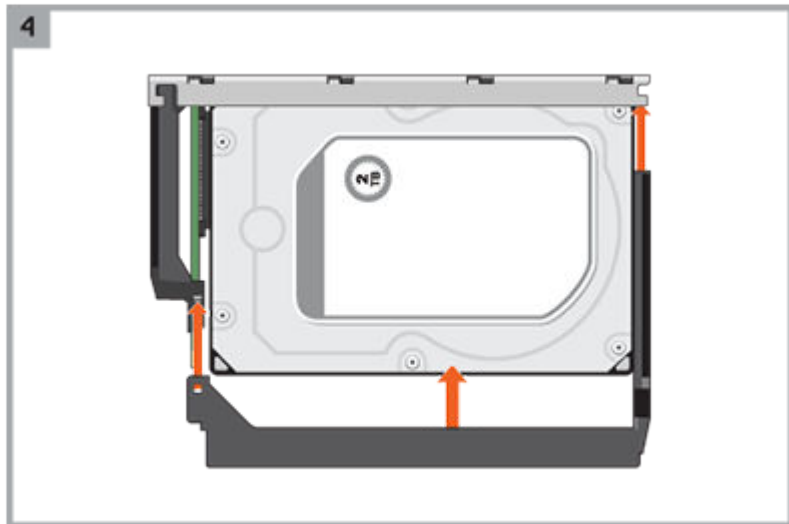
4. Attach the bottom bracket to the new DDIC.

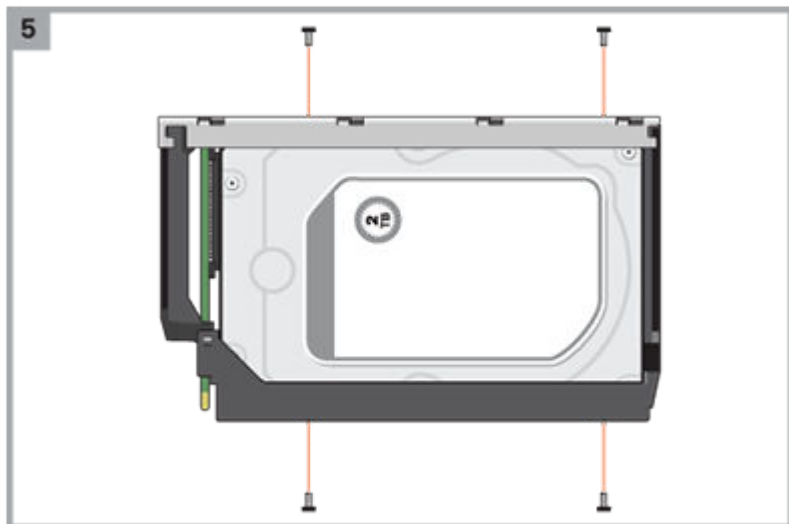
5. Secure the disk drive in the new DDIC using the four screws shipped with the new DDIC.

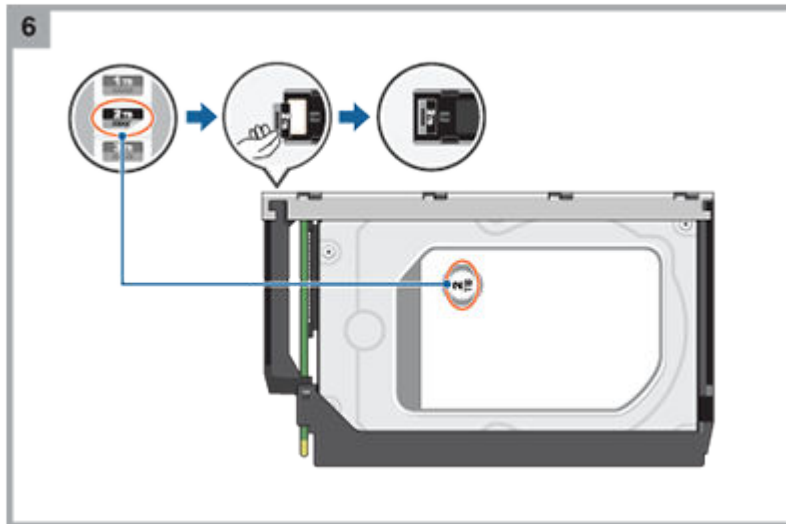
6. Attach the appropriate disk drive size label to the new DDIC.

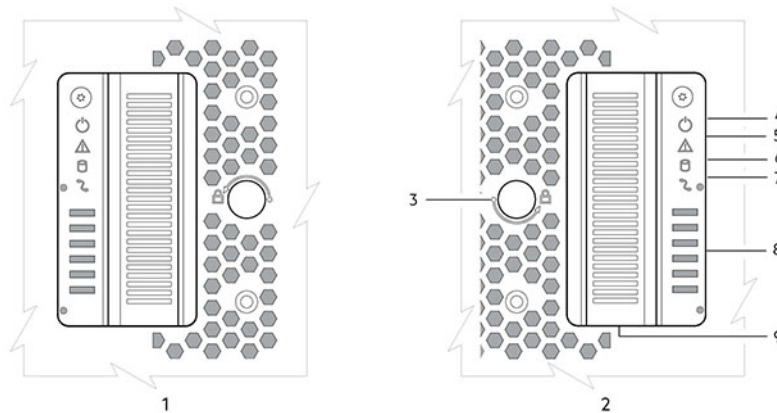
Figure 48. Drawer front panel details

1. Verify that the anti-tamper locks are not engaged. The red arrows on the locks point inwards if the locks are disengaged as shown in the following figure. If necessary, unlock them by rotating counter-clockwise using a Torx T20 bit.

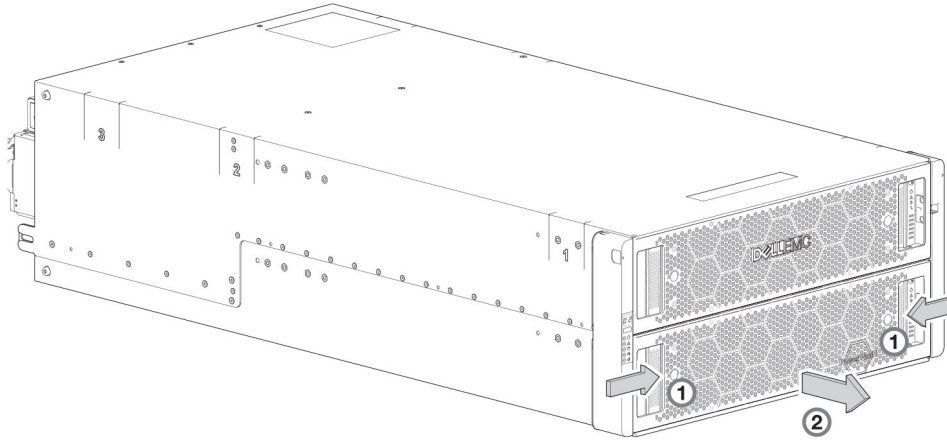
Figure 49. Opening a drawer (1 of 2)

2. Push the drawer latches inward and hold them as shown in the following figure.

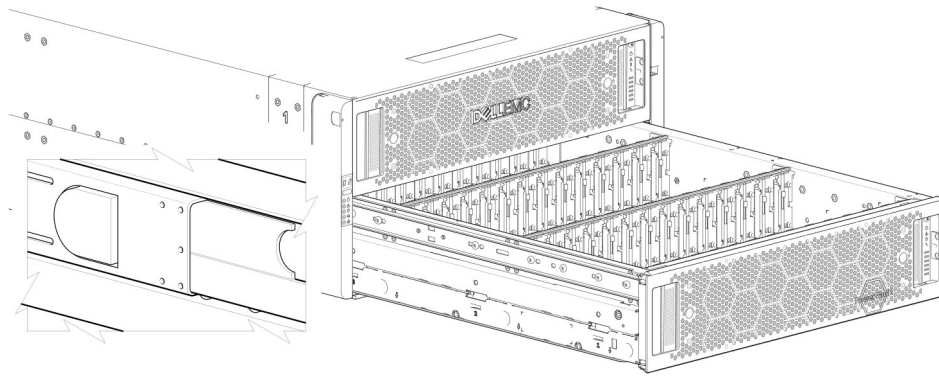
Figure 50. Opening a drawer (2 of 2)

3. Pull the drawer outward until it locks at the drawer stops as shown in the following figure. The drawer is shown empty, which is how the enclosure is delivered. A drawer slide rail latch detail is inset.

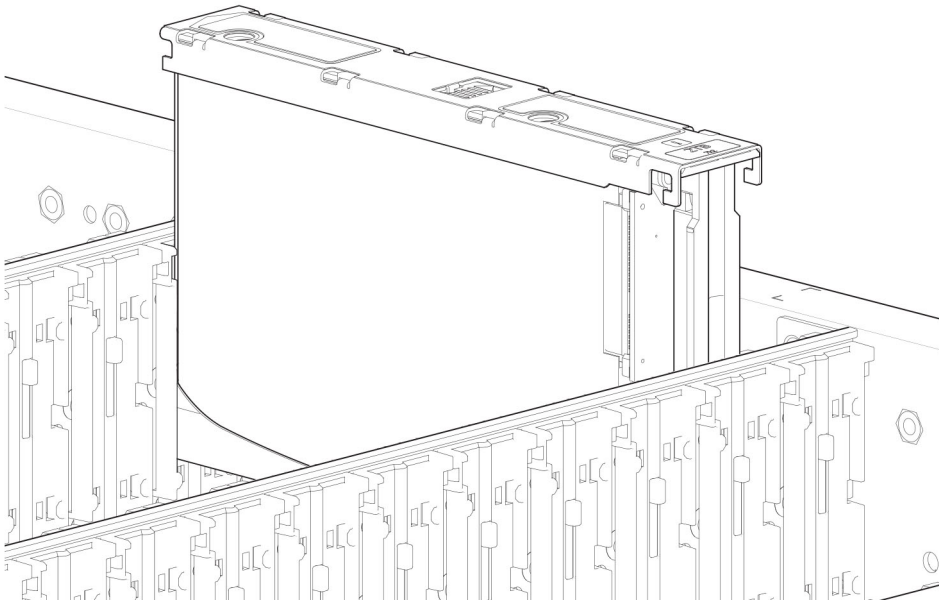
Figure 52. Removing a DDIC (2 of 2)

4. Pull the DDIC upwards and out of the drawer slot.

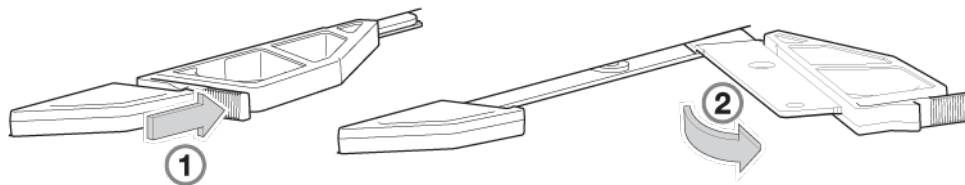
Figure 54. Removing a controller module from an enclosure

1. Verify that you have successfully shut down the controller module using the PowerVault Manager or the CLI.
2. Locate the enclosure with a UID LED that is illuminated.
3. Within the enclosure, locate the controller module with an **OK to Remove** LED that is blue.
4. Disconnect any cables connected to the controller module.
Label each cable to facilitate re-connection to the replacement controller module.
5. Grasp the module latch between the thumb and forefinger, and squeeze the flange and handle together to release the latch handle, and swing the latch handle out to release the controller module from its seated position.

6. Swing the latch handle open, then grip the latch handle and ease the controller module forward from the slot.
7. Place both hands on the controller module body, and pull it straight out of the enclosure such that the controller module remains level during removal.

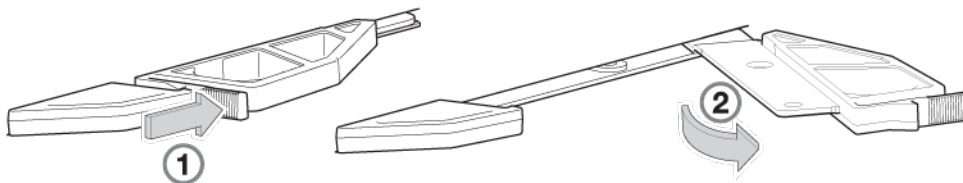
Figure 55. Removing a controller module from an enclosure

1. Shut down the storage system using PowerVault Manager or the CLI.
2. Disconnect any cables connected to the controller module.
Label each cable to facilitate re-connection to the replacement controller module.
3. Grasp the module latch between the thumb and forefinger, and squeeze the flange and handle together to release the latch handle, and swing the latch handle out to release the controller module from its seated position.

4. Swing the latch handle open, then grip the latch handle and ease the controller module forward from the slot.
5. Place both hands on the controller module body, and pull it straight out of the enclosure such that the controller module remains level during removal.

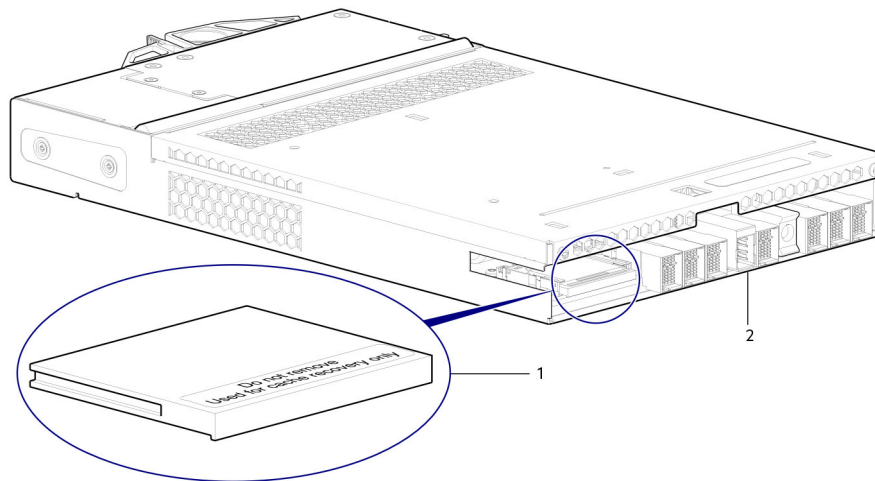
Figure 56. CompactFlash memory card location

1. Remove the failed controller module from the controller enclosure.
2. Locate the CompactFlash memory card at the midplane-facing end of the failed controller module.

- a. CompactFlash memory card
 - b. Controller module viewed from back
3. Grip the CompactFlash memory card and carefully pull it from the slot in the failed controller module.
 4. Label the CompactFlash memory card as Data, and set it aside for safekeeping.
 5. Locate the replacement controller module, and remove its installed CompactFlash memory card.
 6. Insert the CompactFlash memory card from the replacement controller module into the failed controller module. Take care not to confuse this memory card with the memory card labeled Data.
 7. Insert the CompactFlash memory card labeled Data into the replacement controller module. Push the memory card forward until it is seated in place.

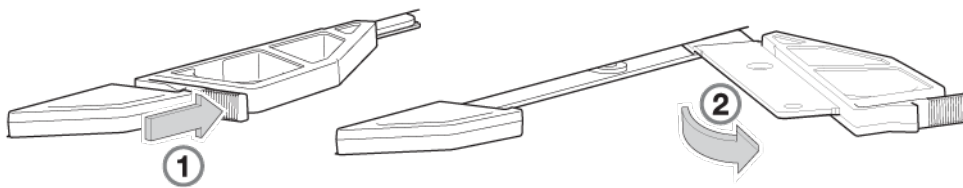
Figure 57. Open module latch

2. Disconnect any cables connected to the IOM. Label each cable to facilitate re-connection to the replacement IOM.
 3. Grasp the module latch between the thumb and forefinger, and squeeze the flange and handle together to release the latch handle, and swing the latch handle out to release the IOM from its seated position.

4. Swing the latch handle open, then grip the latch handle and ease the IOM forward from the slot.
5. Place both hands on the IOM body, and pull it straight out of the enclosure such that the IOM remains level during removal.

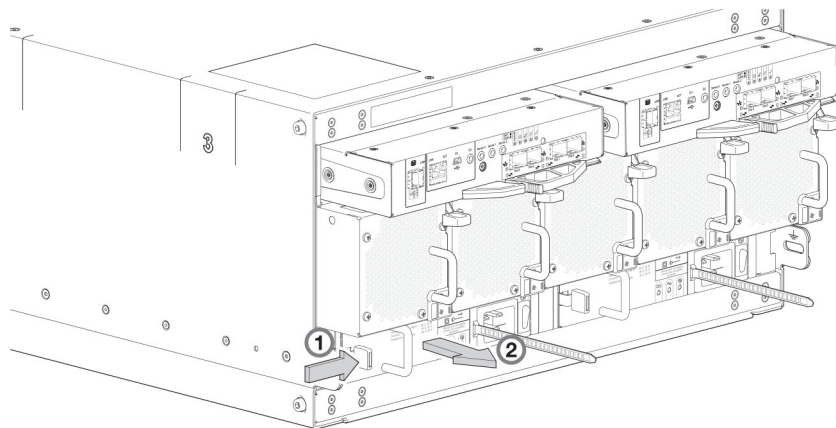
Figure 58. Removing a PSU (1 of 2)

7. Push the release latch to the right and hold it in place (detail No.1).
8. With your other hand, grasp the handle and pull the PSU outward (detail No.2).

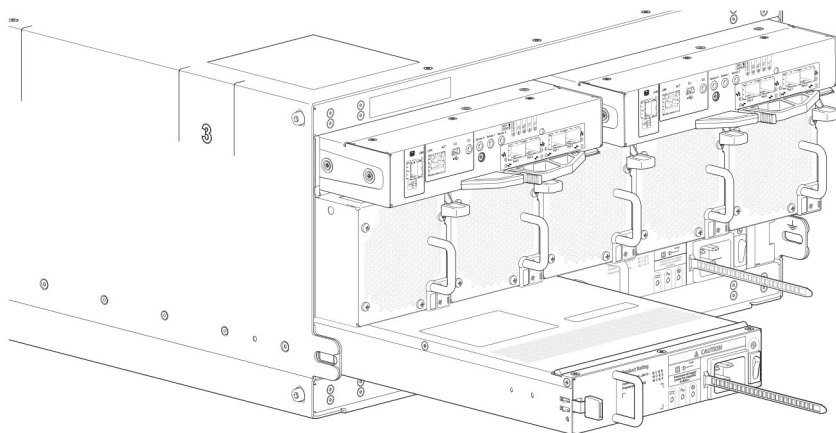
Figure 59. Removing a PSU (2 of 2)

9. While supporting the PSU with both hands, remove it from the enclosure.
10. If replacing both PSUs, repeat steps 5 through 9.

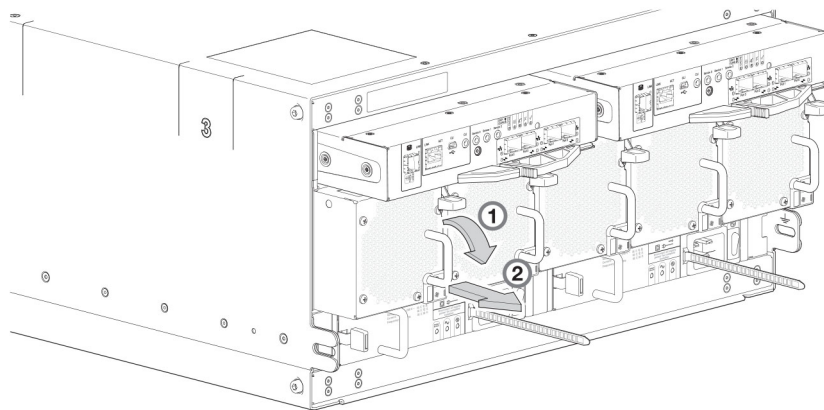
Figure 60. Removing an FCM (1 of 2)

1. Identify the fan cooling (FCM) module to be removed. If the FCM module has failed, the Fan Fault LED will illuminate amber. See [Fan cooling module \(FCM\)](#) on page 19.
2. Push the release latch down and hold it in place (detail No.1).
3. With your other hand, grasp the handle and pull the FCM outward (detail No.2).

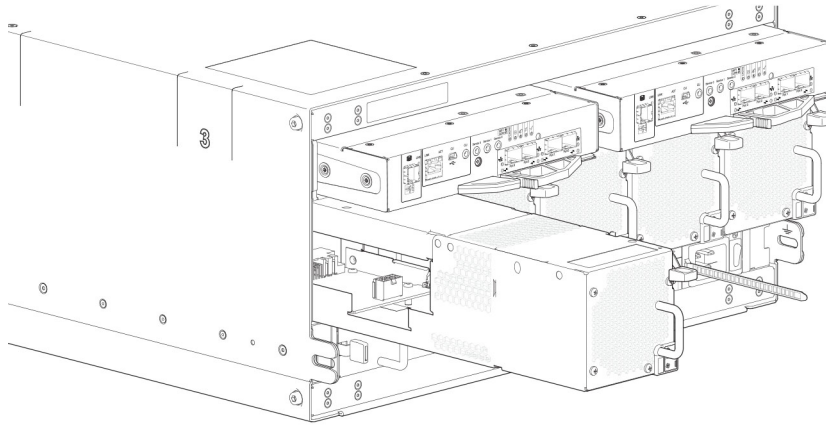
Figure 61. Removing an FCM (2 of 2)

4. While supporting the FCM with both hands, remove it from the enclosure.

1. Orient the FCM for insertion into the target slot on the enclosure rear panel, as shown in [Removing an FCM \(2 of 2\)](#) on page 73.
2. Slide the FCM into the slot until the latch clicks home.
The enclosure should automatically detect and make use of the new module.
3. Wait for the Module OK LED on the newly inserted FCM to illuminate green. See [Fan cooling module \(FCM\)](#) on page 19.
 - If the Module OK LED does not illuminate, verify that the FCM is properly inserted and seated in the slot.
 - If properly seated, the module may be defective. Check the PowerVault Manager and the event logs for more information.
 - Using the management interfaces (the PowerVault Manager or CLI), determine if the health of the new FCM is OK. Verify that the Module OK LED is green, and that the Ops panel states show no amber module faults.
4. If replacing multiple FCMs, repeat steps 1 through 4.

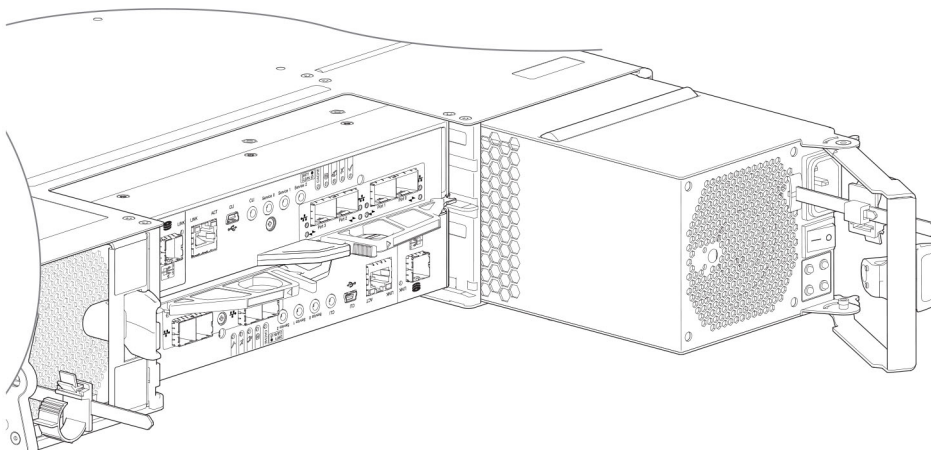
Figure 63. Removing a PCM (2 of 2)

8. Grip the handle and withdraw the PCM, taking care to support the base of the module with both hands as you remove it from the enclosure as shown in the following figure.

i **NOTE:** The remove PCM illustrations show a chassis configured as a 4-port FC/iSCSI controller enclosure. The procedure applies to all 2U controller enclosures and expansion enclosures.

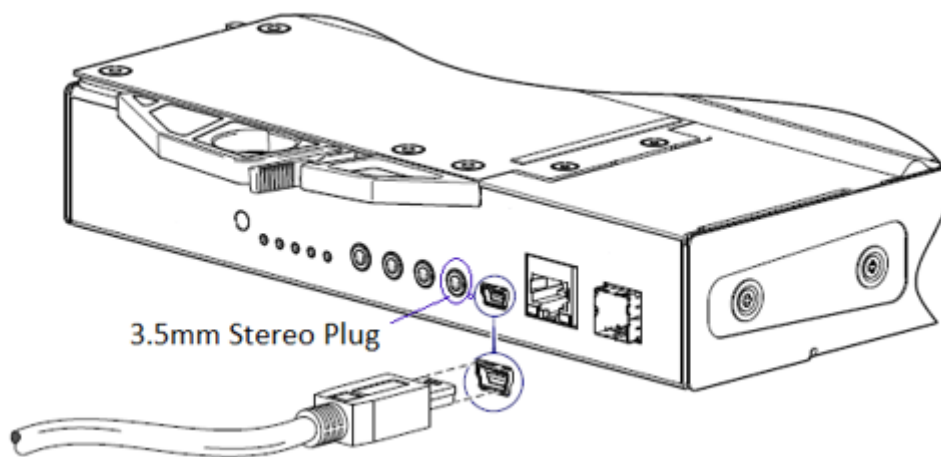
The mini-USB connector plugs into the USB CLI port as shown in the following figure:

Figure 64. Connecting a USB cable to the USB CLI port

1. Connect the 3.5mm/DB9 serial cable from a computer with a serial port to the 3.5mm stereo plug CLI port on controller A. Alternatively, connect a generic mini-USB cable (not included) from a computer to the USB CLI port on controller A.
