Assembly (71) into Left Gearcase (64)

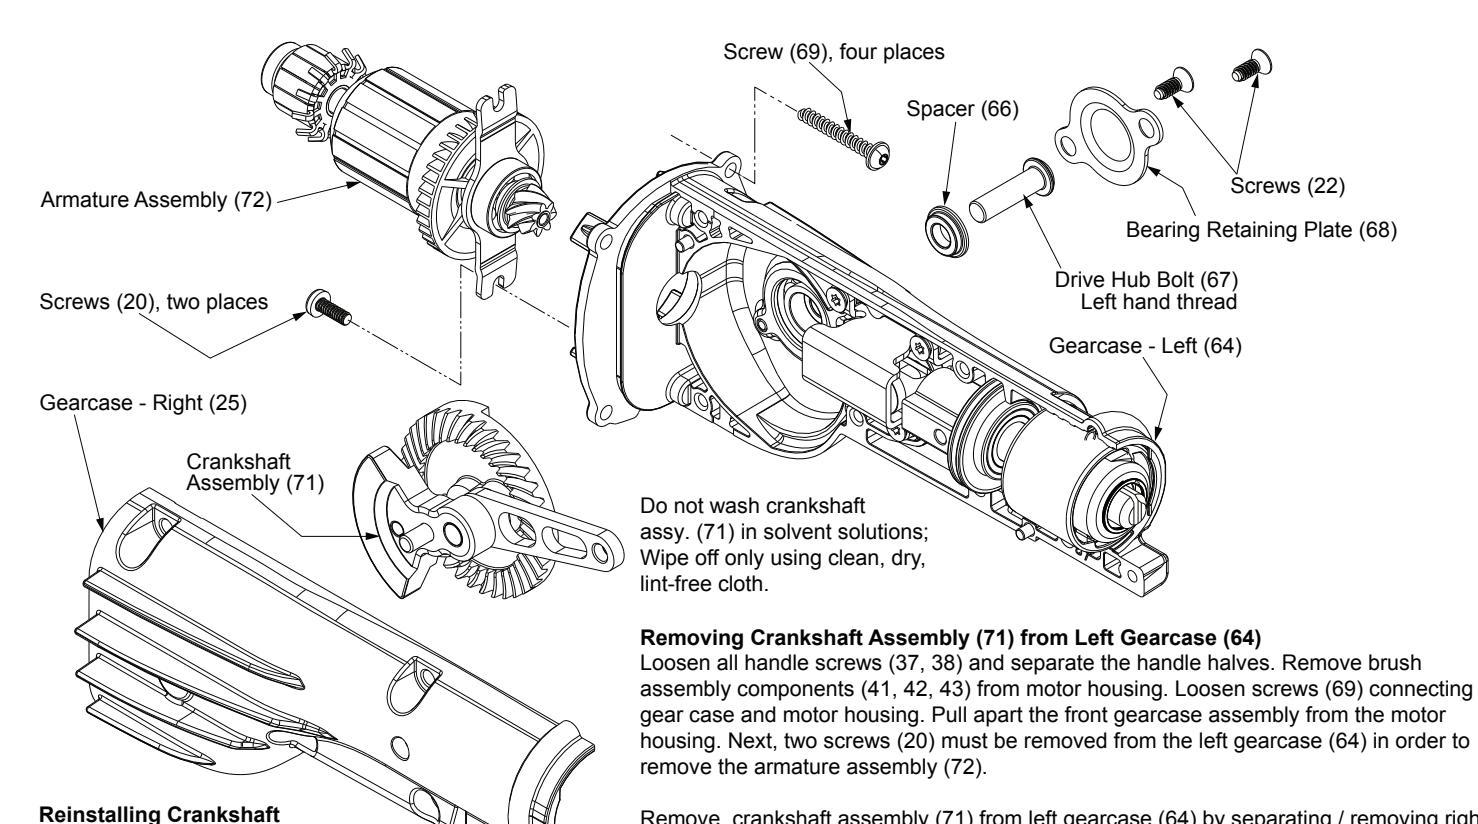
Remove, crankshaft assembly (71) from left gearcase (64) by separating / removing right gearcase half (25). Remove bearing retaining plate screws (22) and bearing plate (68) from left gearcase (64). Place a $3/16^{\circ}$ diameter x $1-1/2^{\circ}$ long steel rod through the holes found in counter balance and drive hub of crankshaft assembly (71) until it bottoms out.

Next place a T-40 torx drive into drive hub bolt (67) and turn drive hub bolt slowly in a clockwise direction until 3/16" steel pin rest against crankshaft assembly connecting rod. The T-40 torx drive can now be forcibly turned clockwise to loosen and remove drive hub bolt (67).
