SpotClean
5207 9749 7786

Machine Leaking Out of bottom

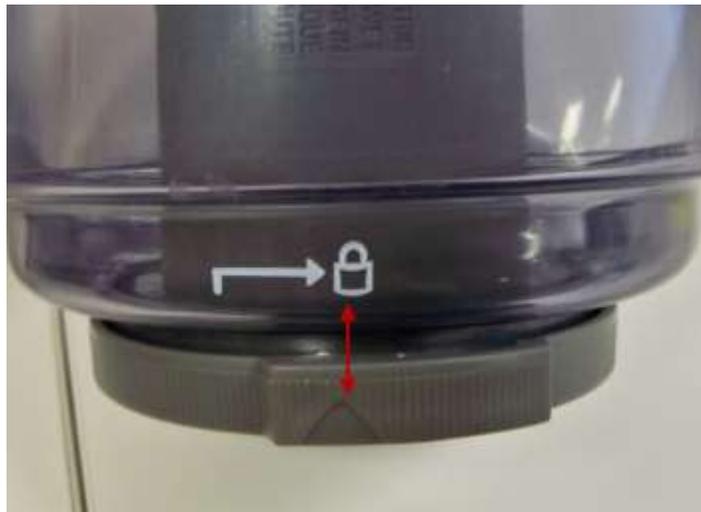
- 1) **Ask the consumer to describe what they mean by “bottom.”** If they state the machine is leaking from the bottom of the solution tank, follow troubleshooting for *“Solution Tank is Leaking.”* If they state it is leaking from the collection tank, follow Troubleshooting for *“Leaking from Collection Tank.”*
- 2) Make sure the separator stack inside the collection tank is in place properly. The arrow on the separator stack should be in line with the lock icon on the collection tank. If it is not locked into place, the collection tank will leak or it will leak out of the bottom of the machine. See picture:
